CLARION UNIVERSITY | CLARION CAMPUS
Facilities Master Plan Appendix

D BUILDINGS LAYOUTS AND ASSESSMENT

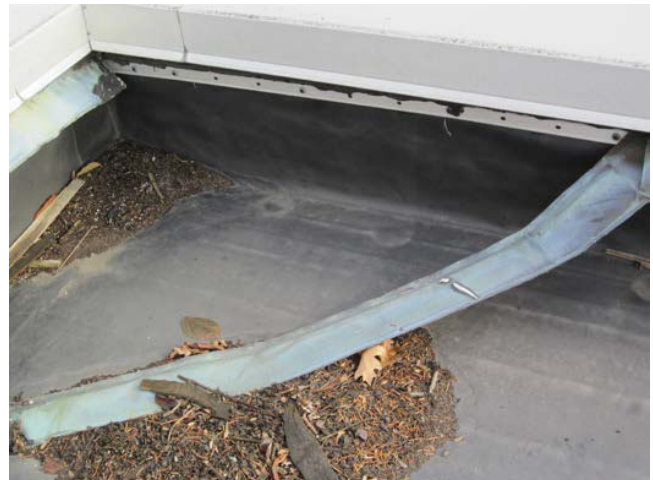
Figure 6: Loose copper flashing at roof

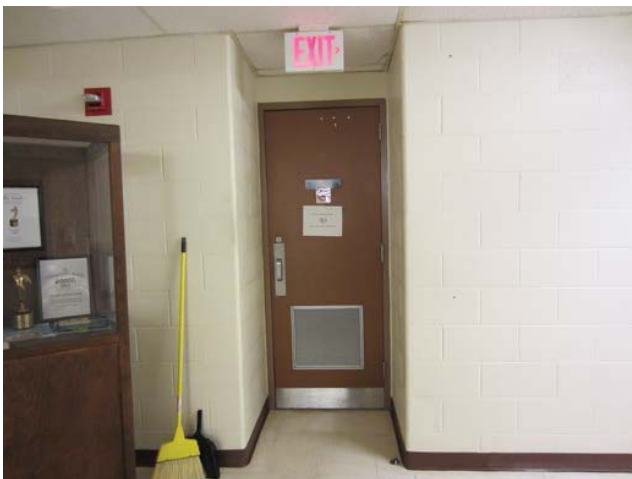
Figure 7: Non-compliant clearances at toilet room entry for accessibility

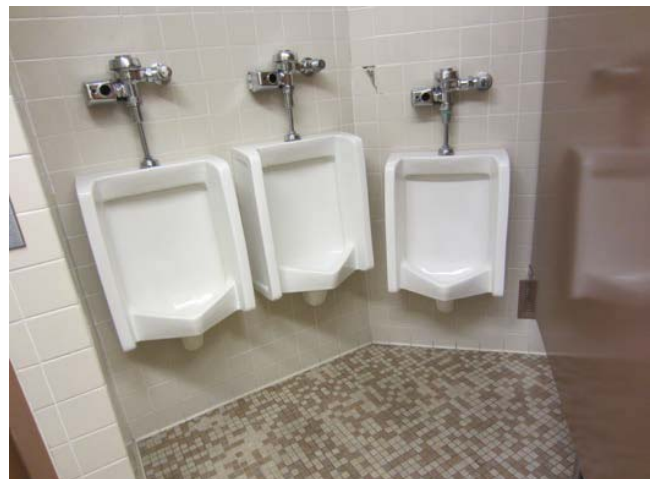
Figure 8: Non-compliant fixture clearances for accessibility. Cracked, broken wall tile.

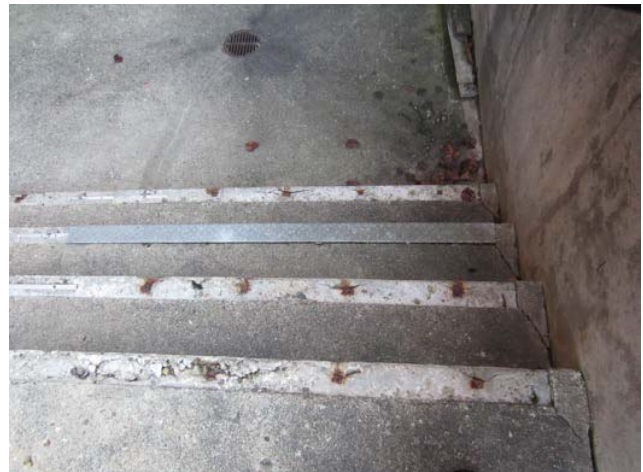
Figure 4: Cracking and spalling at concrete steps, broken and missing steel nosings.

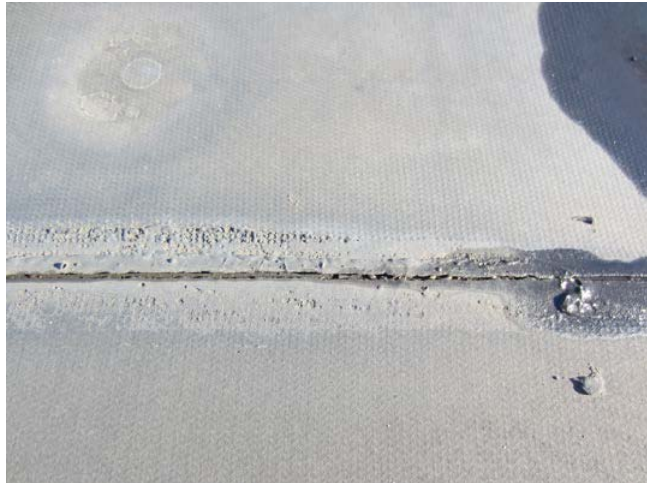
Figure 6: Deterioration at roof membrane seam

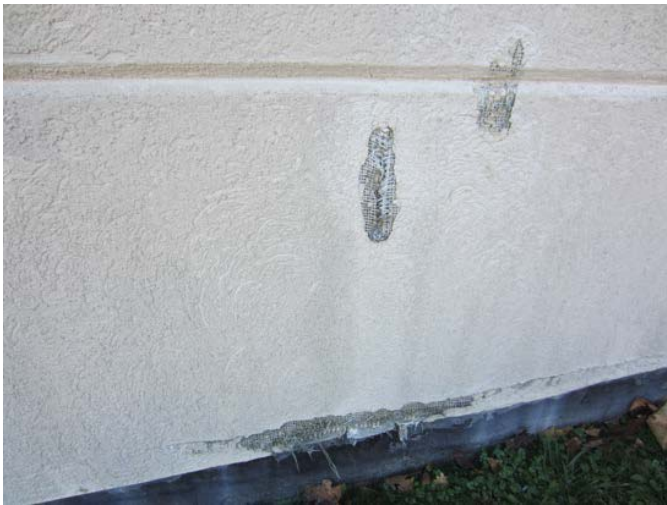
Figure 5: Stucco damage at building exterior

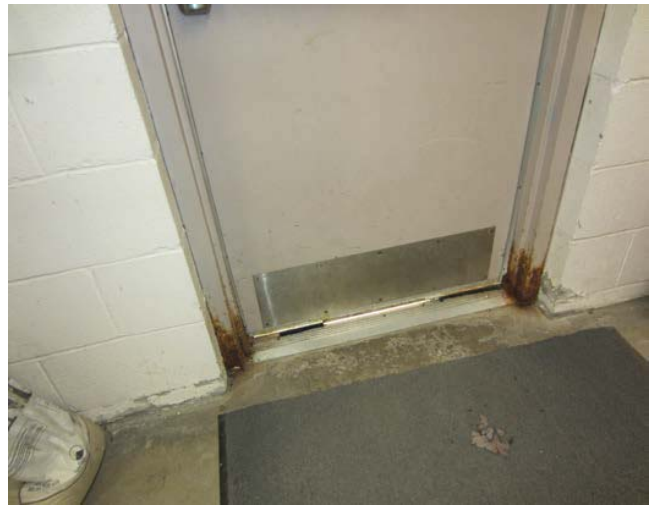
Figure 6: Hollow metal frame corrosion

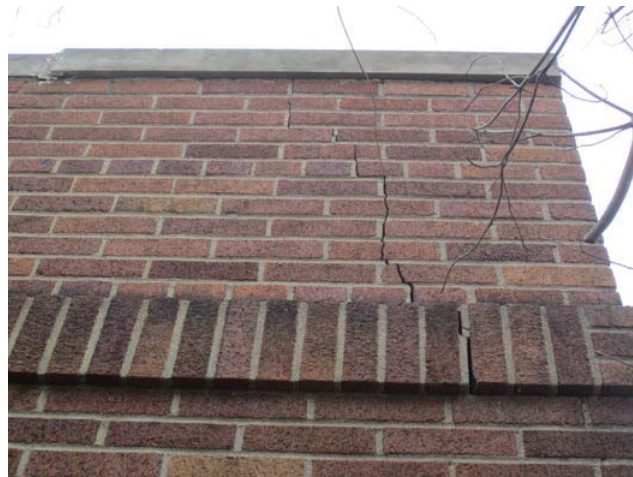
Figure 2: Cracked masonry and open mortar joints (typical)

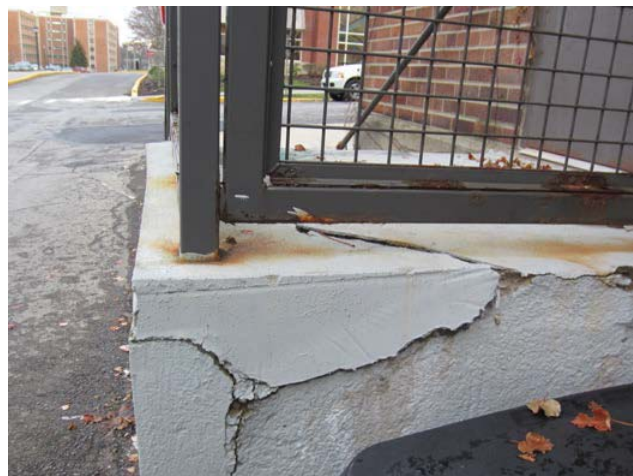
Figure 4: Concrete spalling at entrance

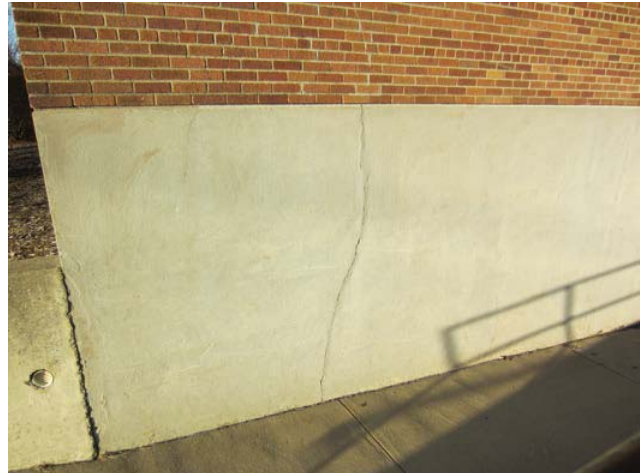
Figure 2: Cracking at foundation wall, south facade

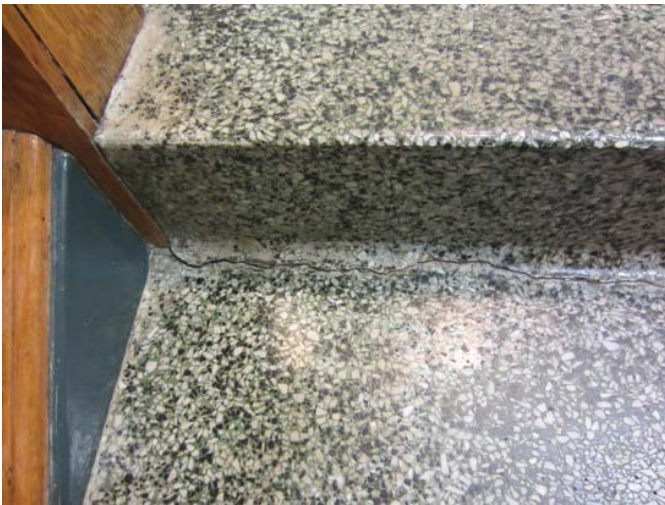
Figure 5: Cracked terrazzo stair finish in atrium

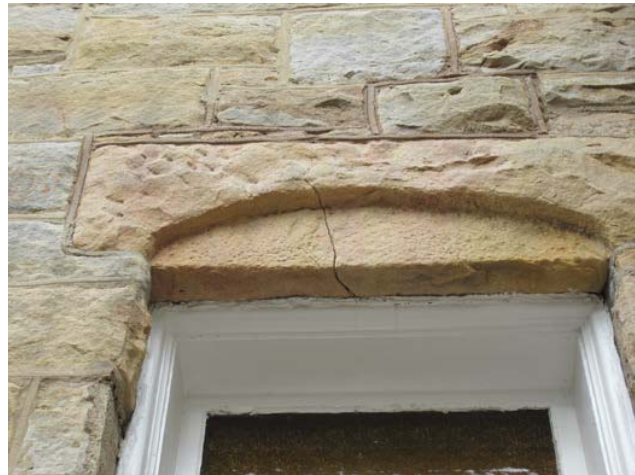
Figure 2: Cracked stone lintel

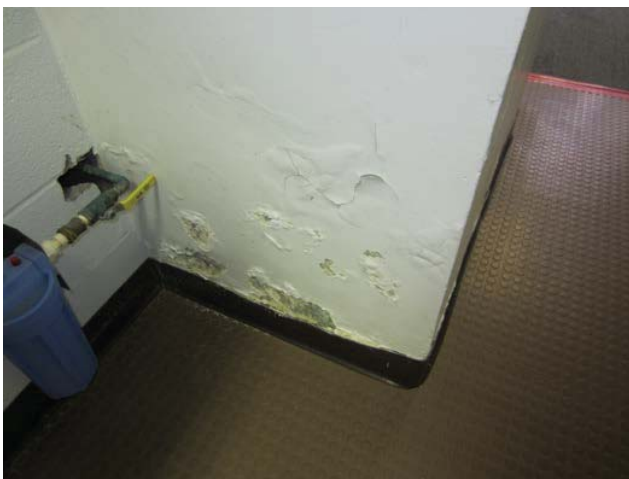
Figure 3: Moisture damage at basement level

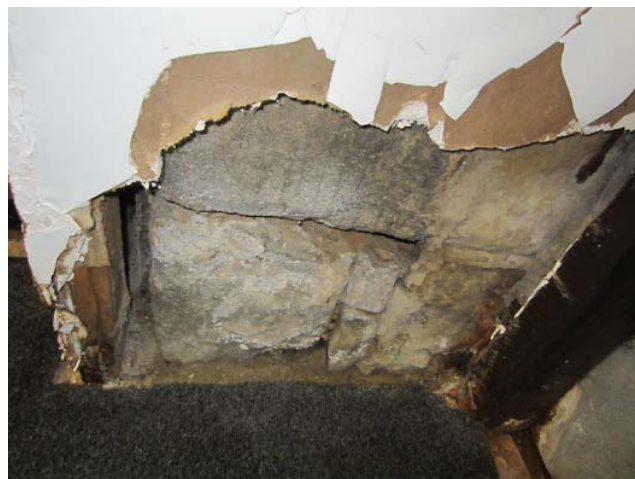
Figure 4: Moisture damage and corrosion at entry

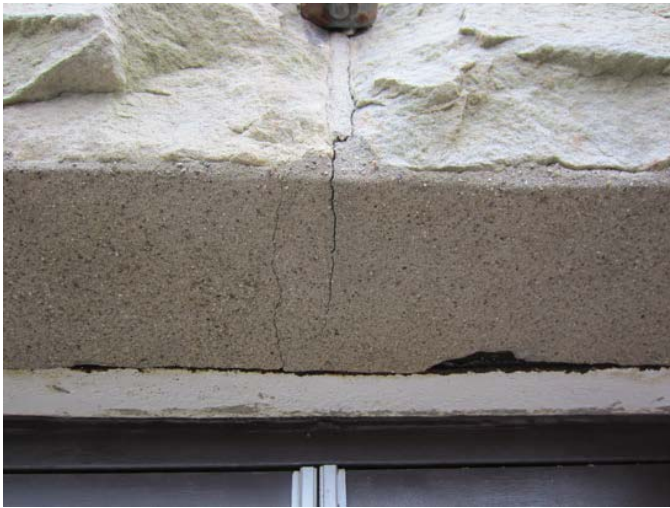
Figure 5: Crack in concrete repair to stonework, above doorway.

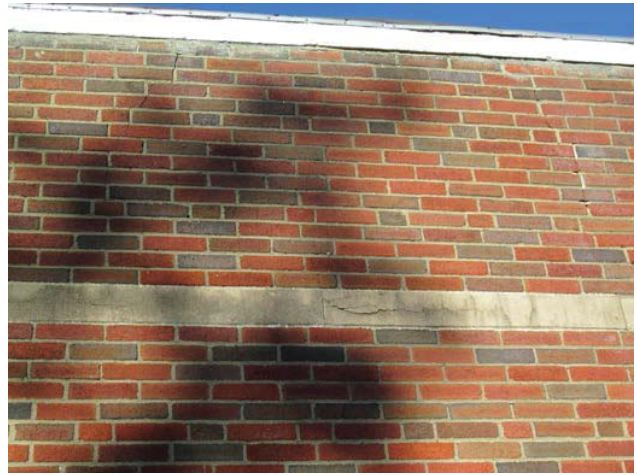
Figure 2: Cracked brick and mortar, spalling cast stone

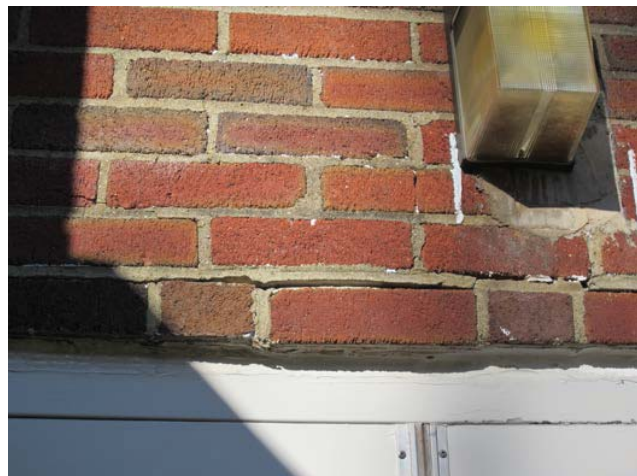
Figure 4: Cracks and open joints in mortar, masonry movement above doorway

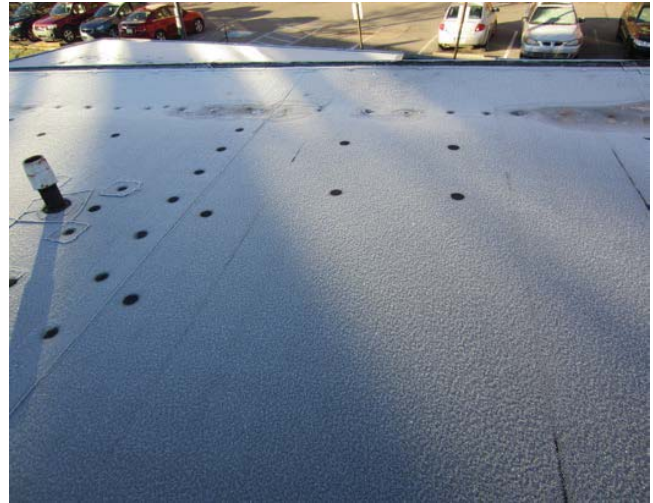
Figure 6: Membrane roof, illustrating thermal leaks at points of attachment.

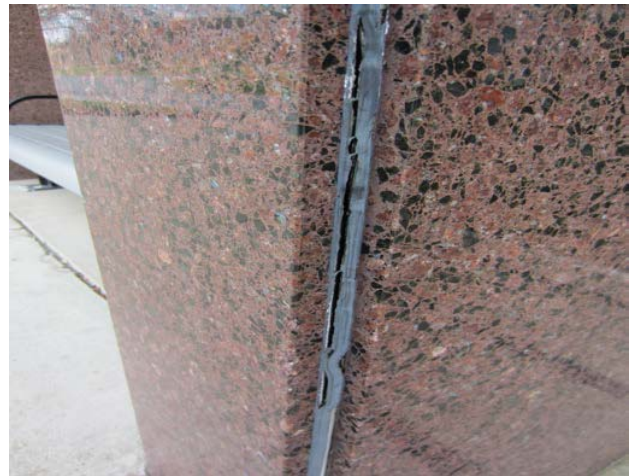
Figure 4: Sealant failure at marble panel joint

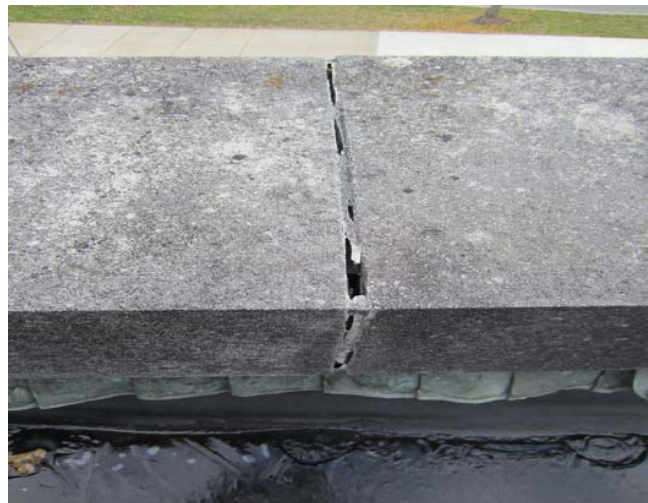
Figure 6: Sealant failure at limestone coping

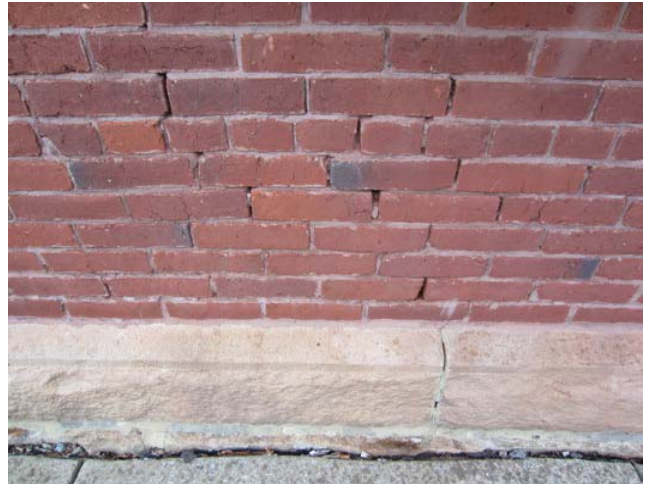
Figure 2: Cracks and open joints in exterior masonry

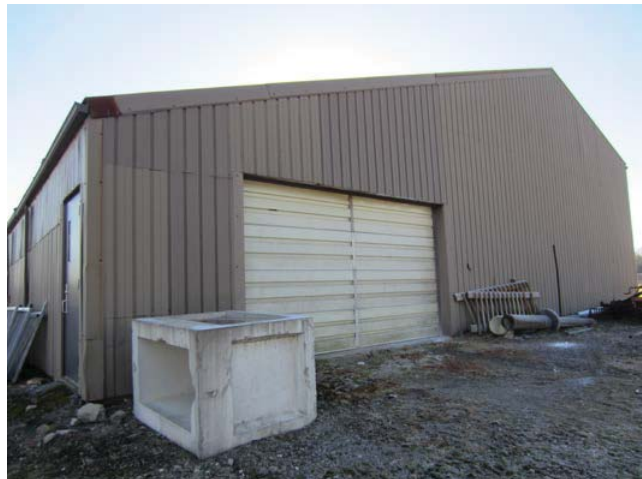
Figure 2: Exterior corrosion at roof flashing and impact damage at wall panels

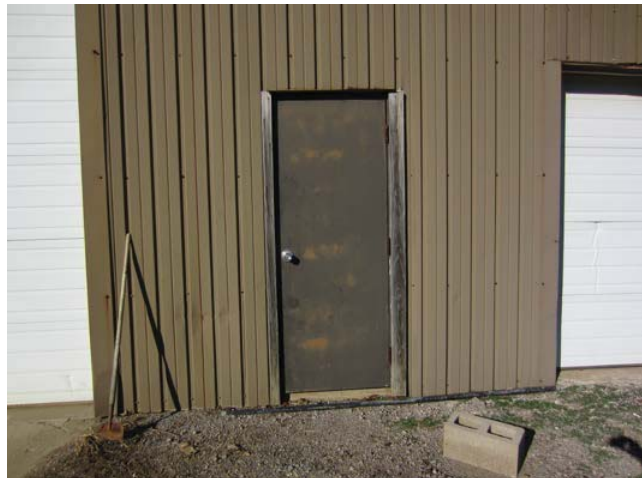
Figure 4: Door, hinge and wood jamb deterioration at hollow metal entrance.

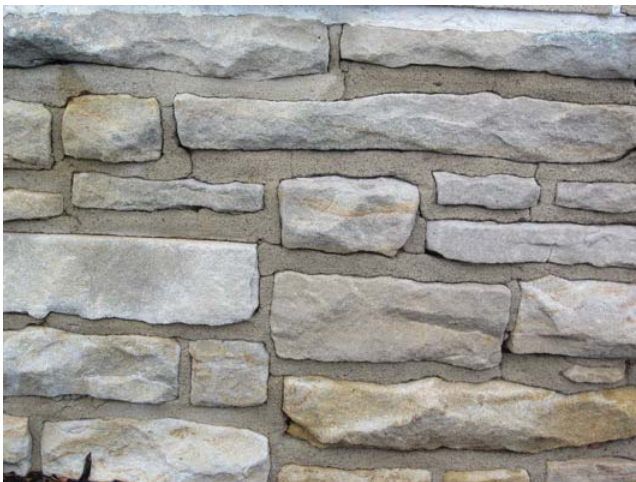
Figure 3: Cracks in stone masonry

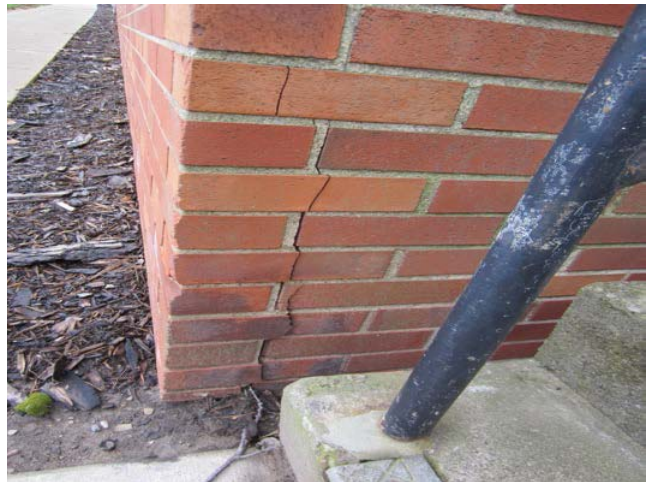
Figure 4: Cracks in brick masonry

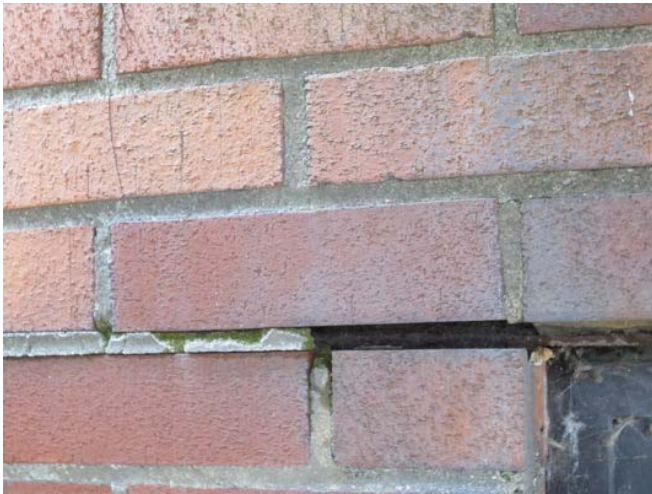
Figure 5: Window lintel corrosion cracking masonry and mortar joints

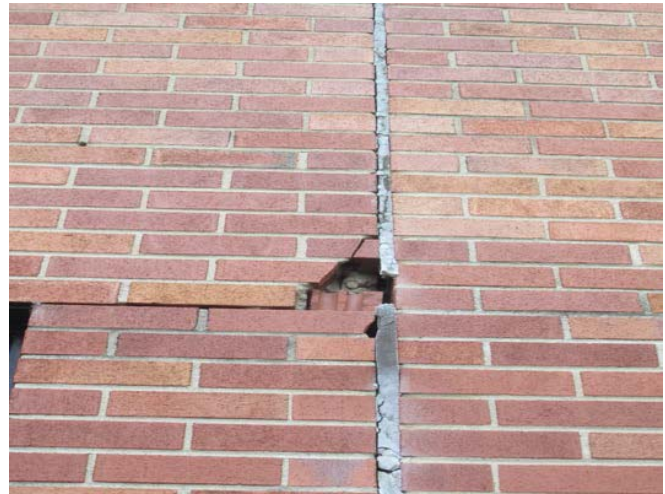
Figure 6: Sealant failure at expansion joint, with masonry spalling and cracking.

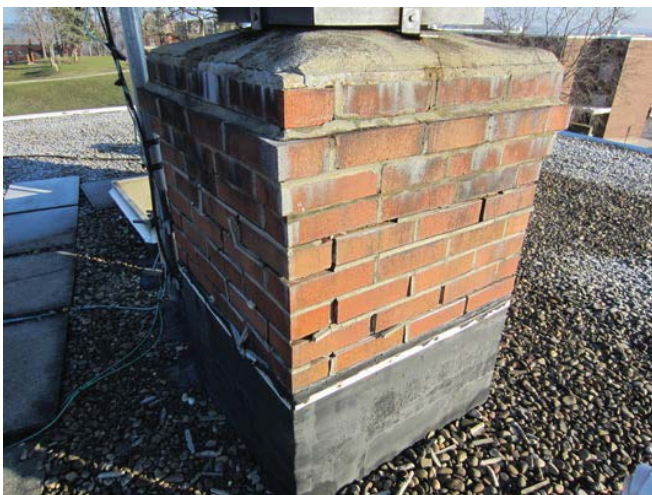
Figure 7: Open joints and cracks in chimney masonry

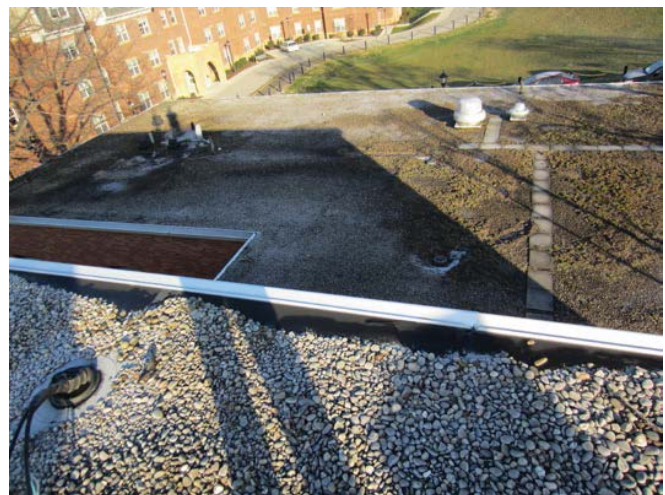
Figure 8: Plant growth on lower roof, beyond

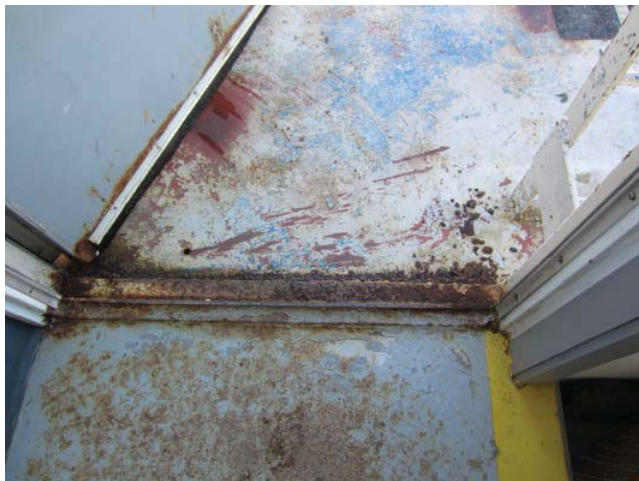
Figure 3: Corrosion at pressbox entrance

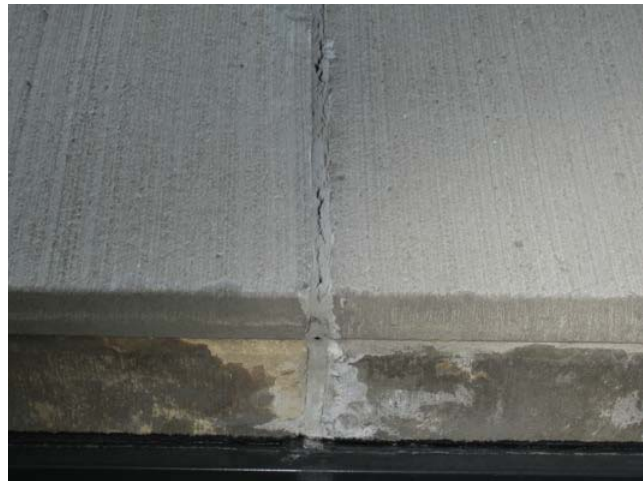
Figure 2: Sealant failure between precast panels

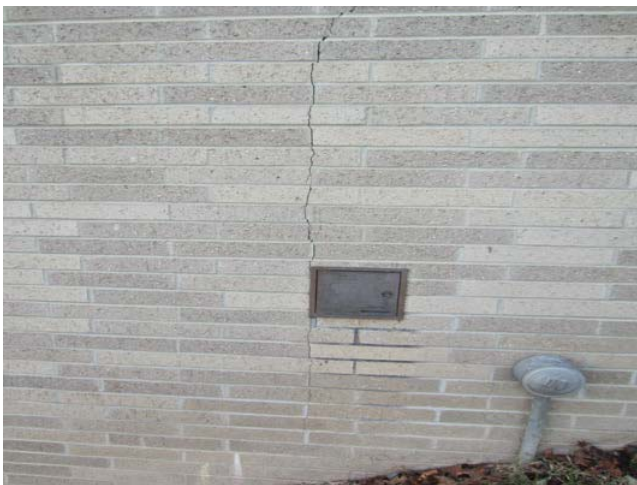
Figure 3: One of multiple vertical masonry cracks

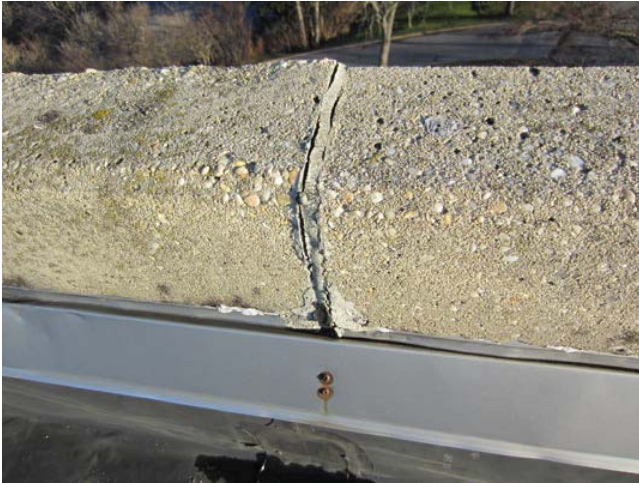
Figure 5: Spalling and sealant failure at roof coping

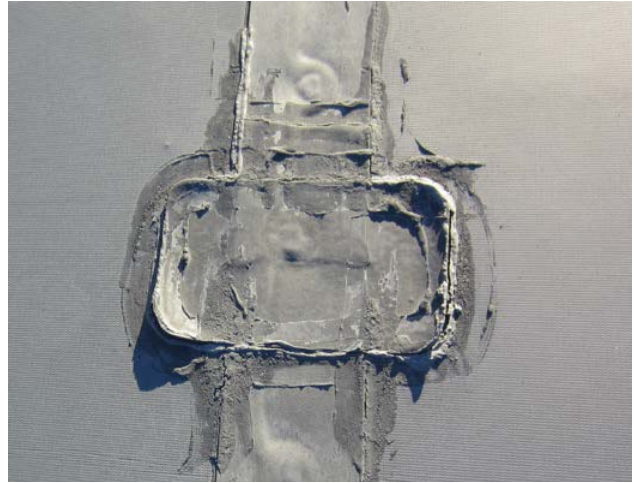
Figure 6: Deterioration at roof membrane edges (typical)

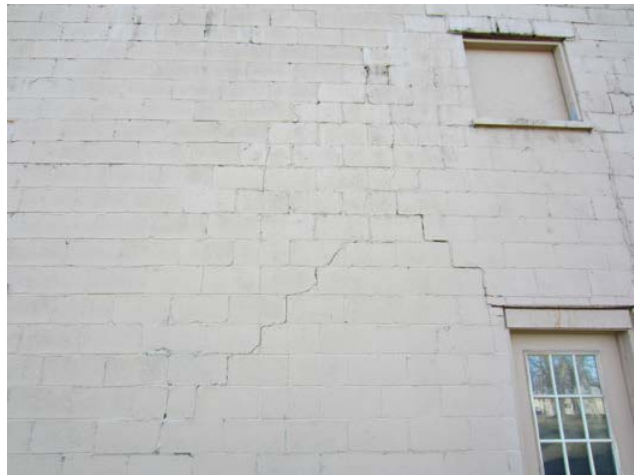
Figure 2: Cracked concrete masonry (typical)

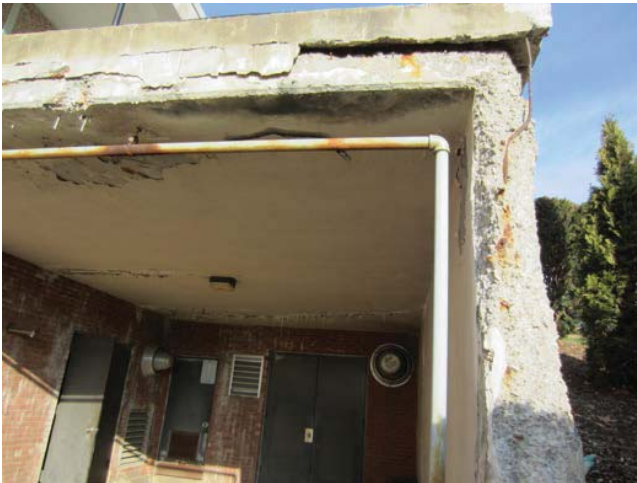
Figure 7: Concrete deterioration at service entrance

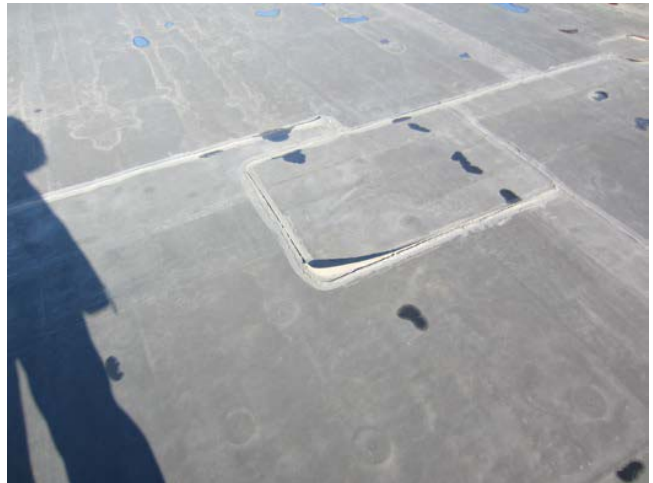
Figure 8: Seam separation between roof membrane materials (typical)

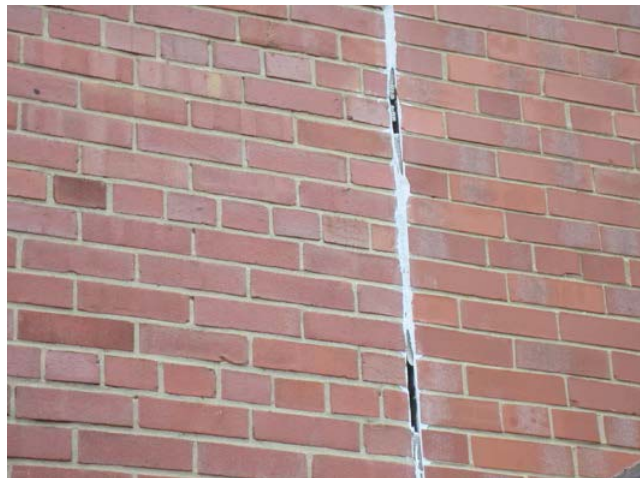
Figure 2: Sealant failure and open joint in masonry at expansion joint

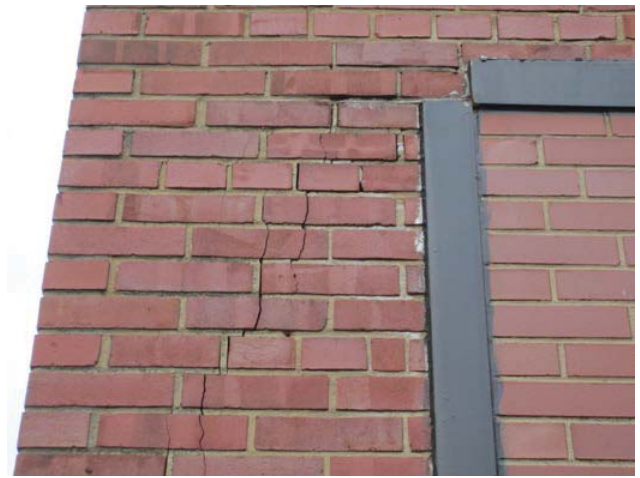
Figure 4: Cracked brick masonry and mortar

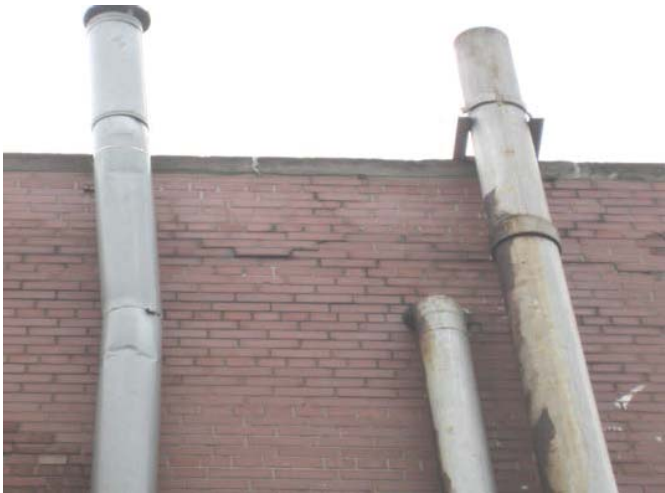
Figure 5: Masonry cracks and brick displacement

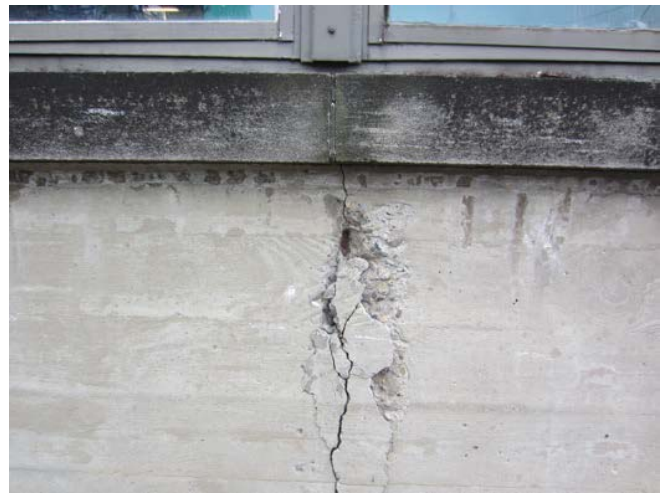
Figure 6: Cracking and spalling of concrete

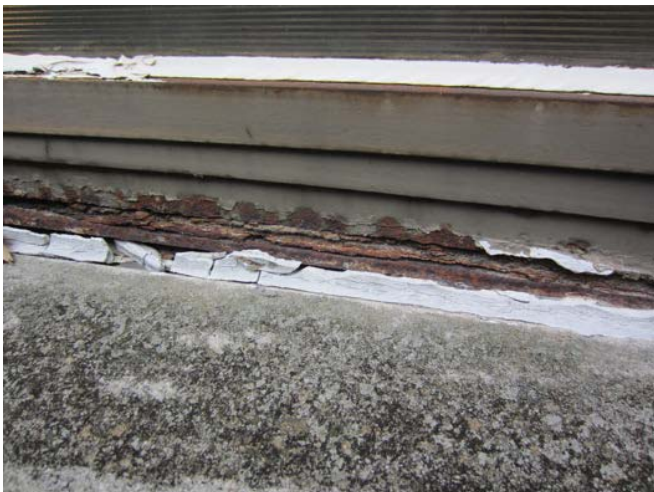
Figure 7: Window frame corrosion and sealant failure at sill

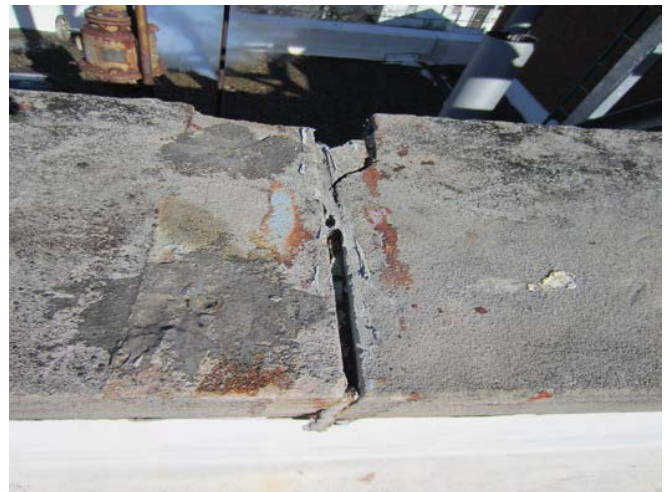
Figure 8: Cracked and broken coping, open joint resulting from mortar and sealant failure.
