CLARION UNIVERSITY | CLARION CAMPUS
Facilities Master Plan Appendix

D BUILDINGS LAYOUTS AND ASSESSMENT

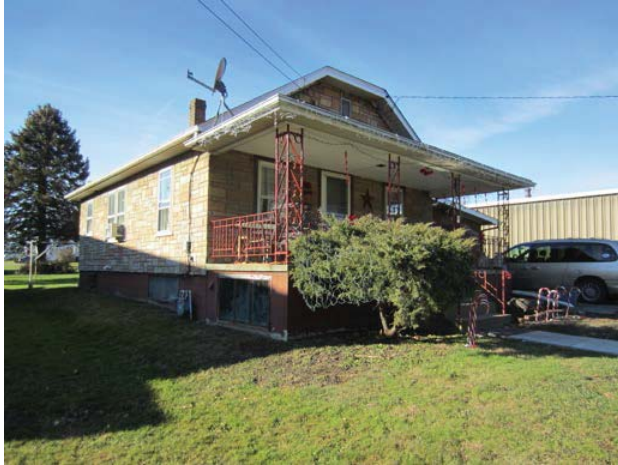
Figure 1: 206 Wilson Avenue exterior view

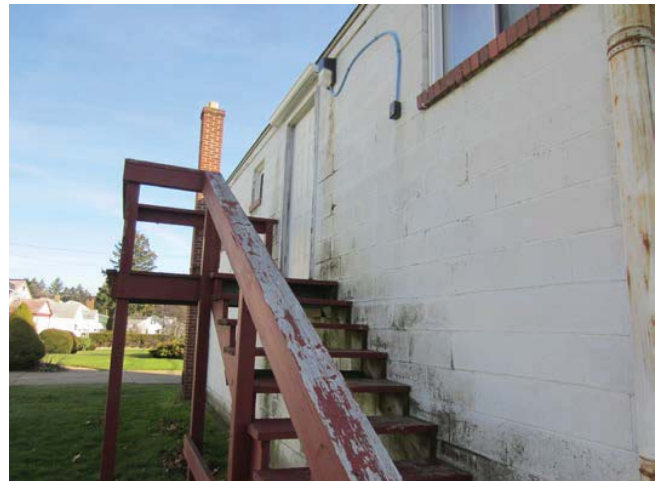
Description	Concrete masonry, brick veneer, wood and aluminum siding.
Condition	Fair
Rating:	2.0
Recommendations	Maintain exterior enclosure condition.

Figure 2: Building exterior finishes

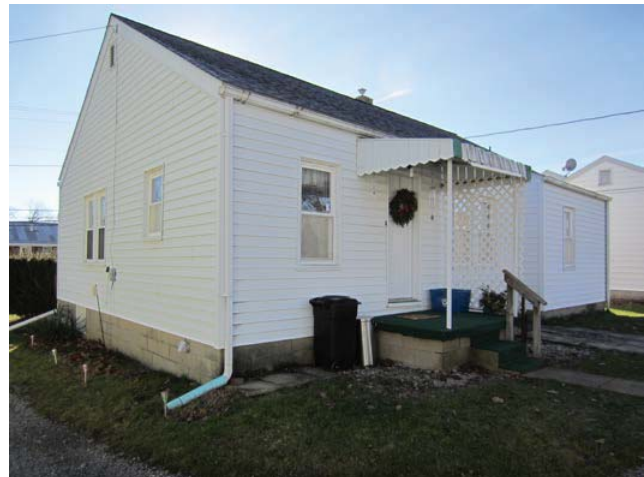
Figure 2: Building rear, exterior finishes

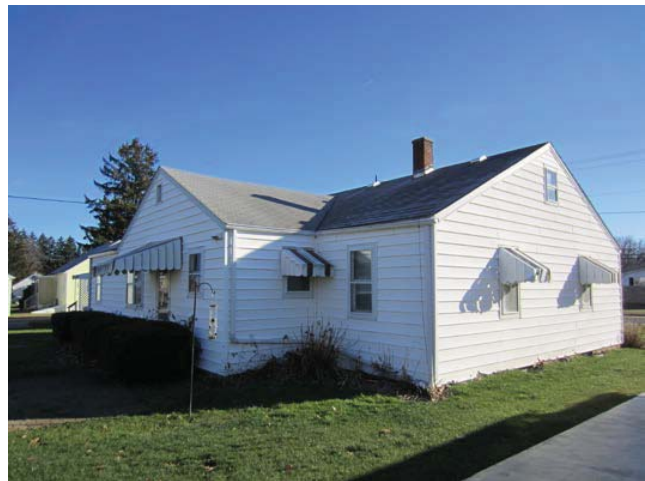
Figure 2: Building rear, exterior finishes

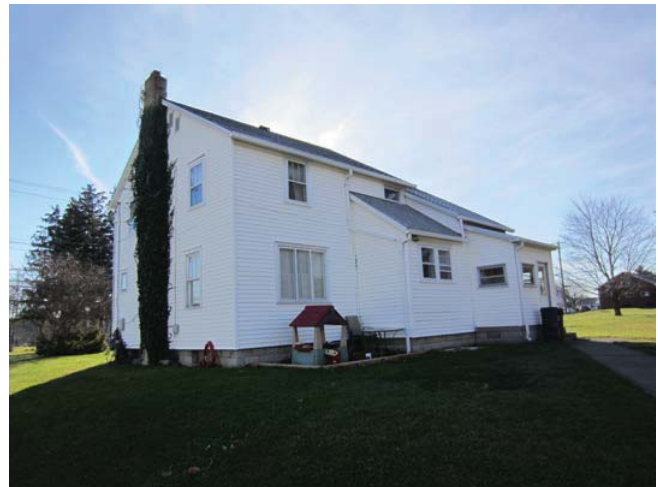
Figure 2: Building rear, exterior finishes

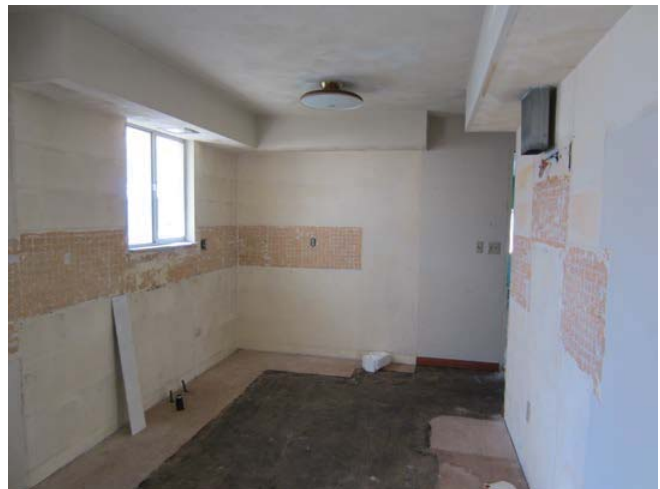
Figure 2: Interior view of former kitchen

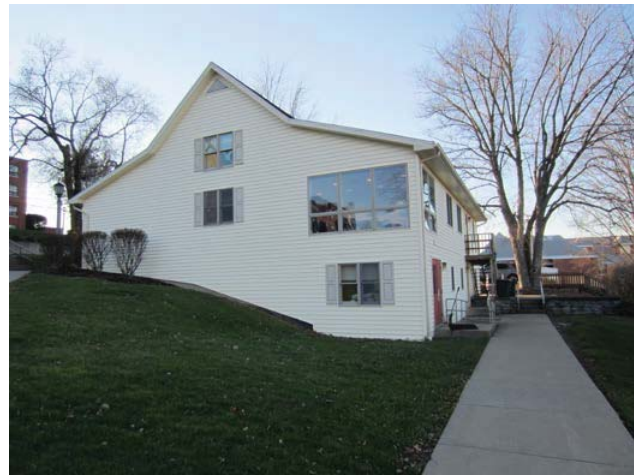
Figure 2: East and north facades of building

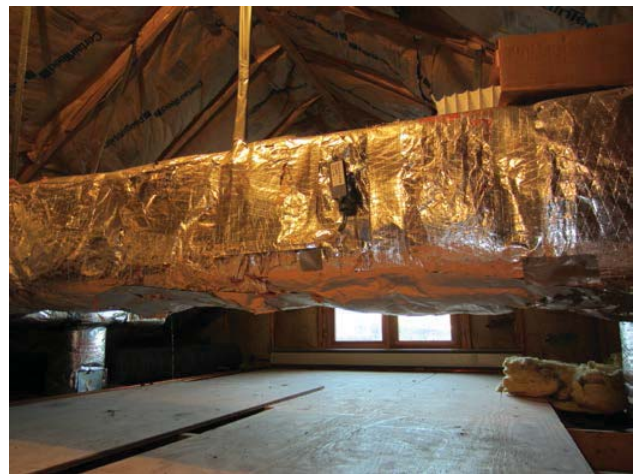
Figure 4: Attic interior with distribution ductwork

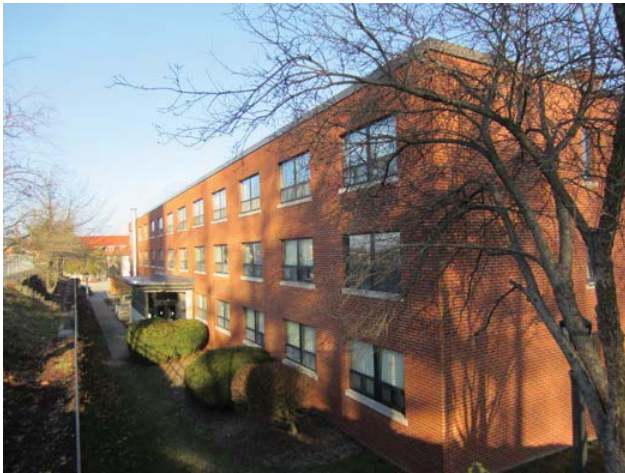
Figure 1: South façade of Ballentine Hall, from top of retaining wall

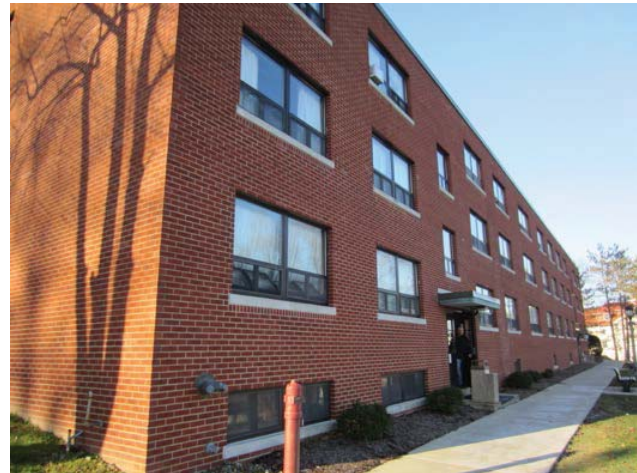
Figure 2: North façade of the building, with basement windows

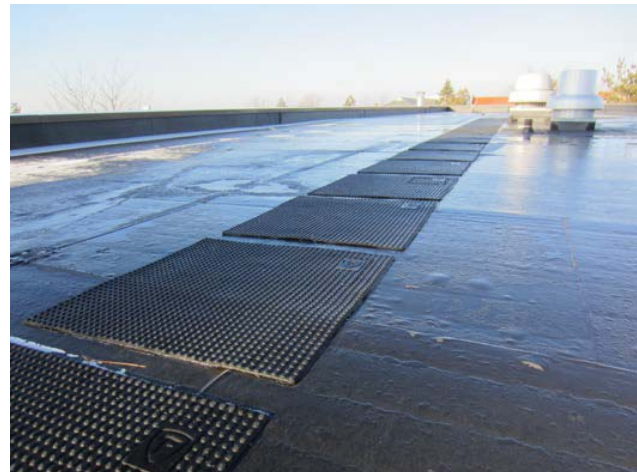
Figure 4: View of membrane roofing

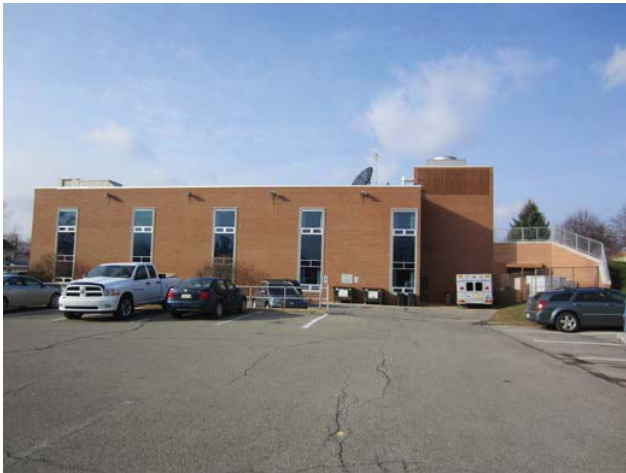
Figure 1: Becker Hall viewed from the east

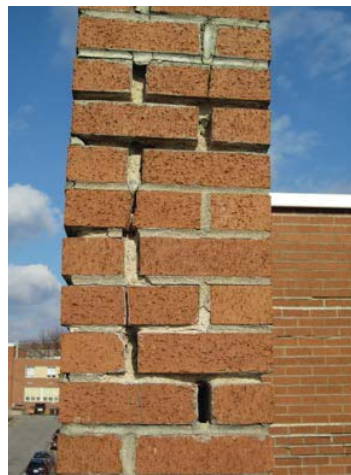
Figure 4: Masonry condition at screen wall

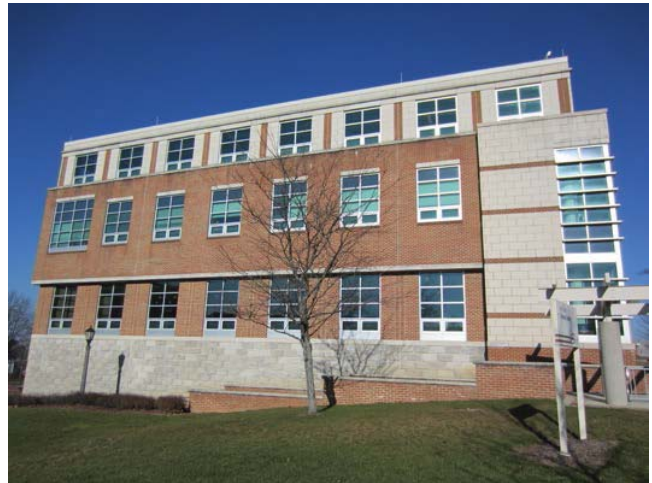
Figure 2: South façade of Carlson Library

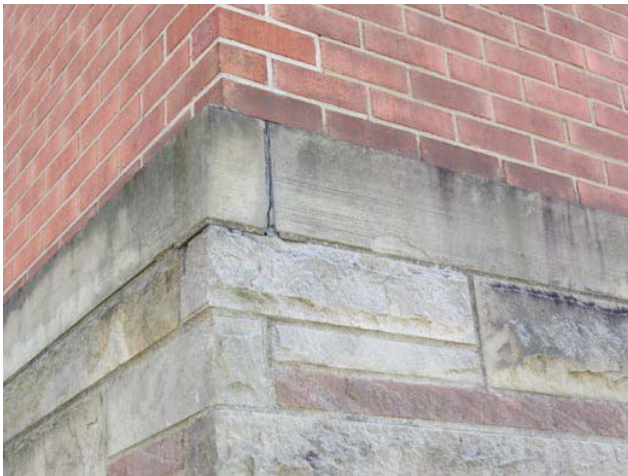
Figure 3: Mortar cracks at ashlar stonework

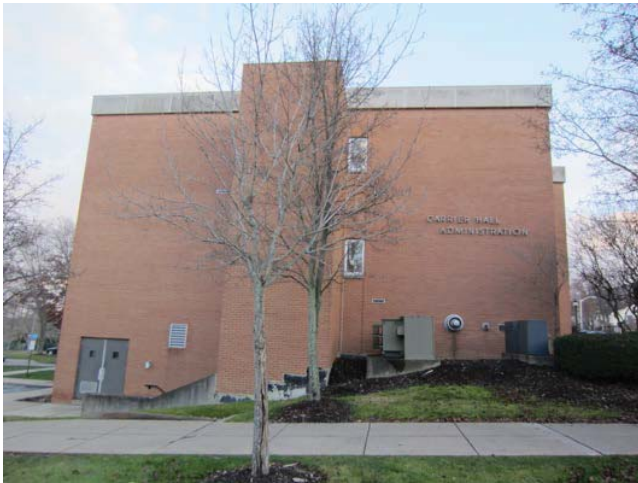
Figure 1: West façade of Carrier Administration Building, illustrating site slope

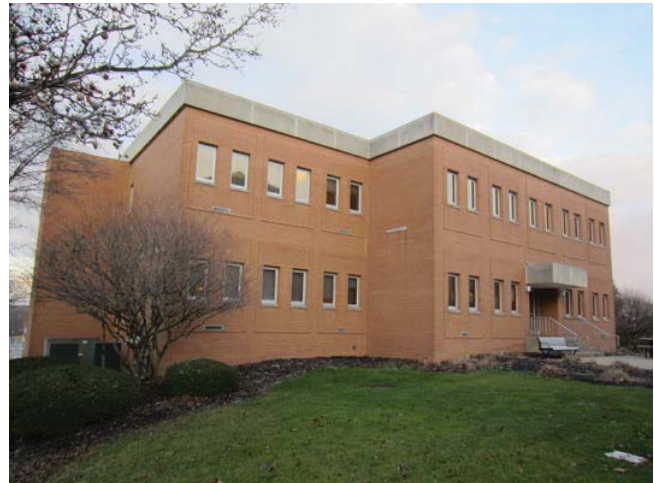
Figure 2: South façade of building, with first floor entrance

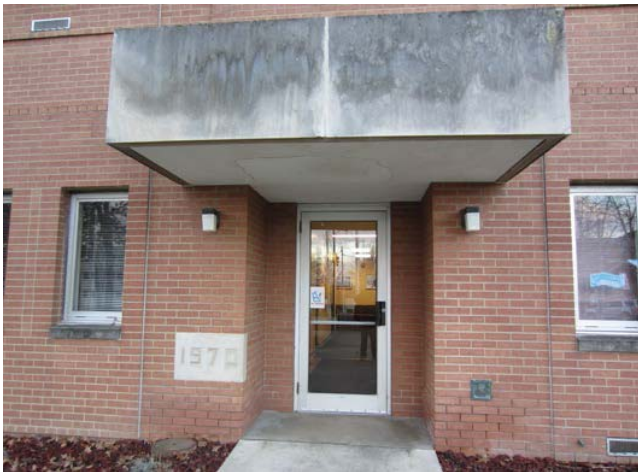
Figure 3: Masonry stains and open mortar joints at entry

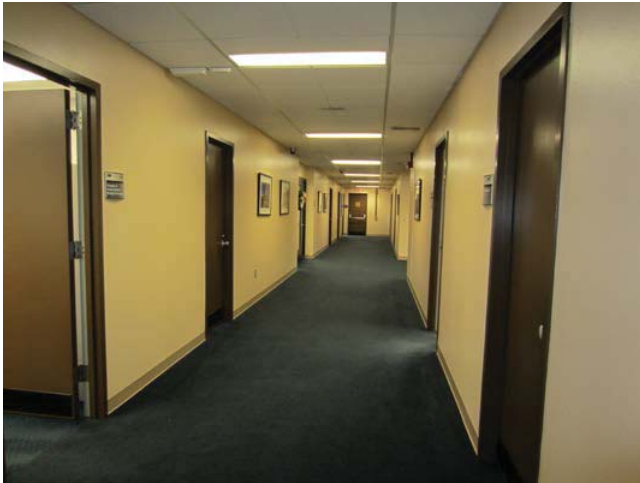
Figure 5: Interior view of office corridor

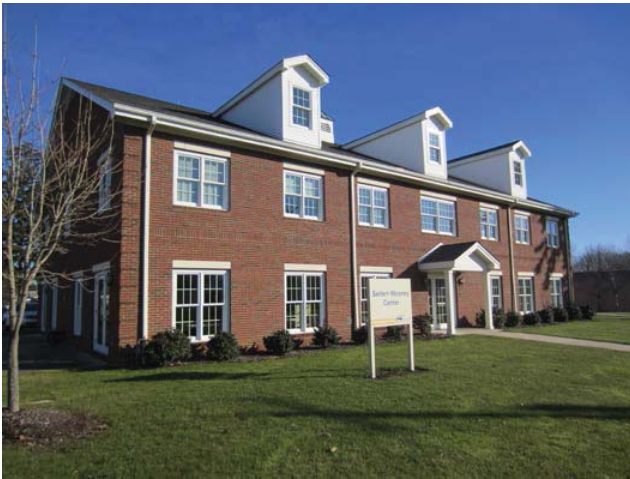
Figure 1: West façade of the Center for Advancement

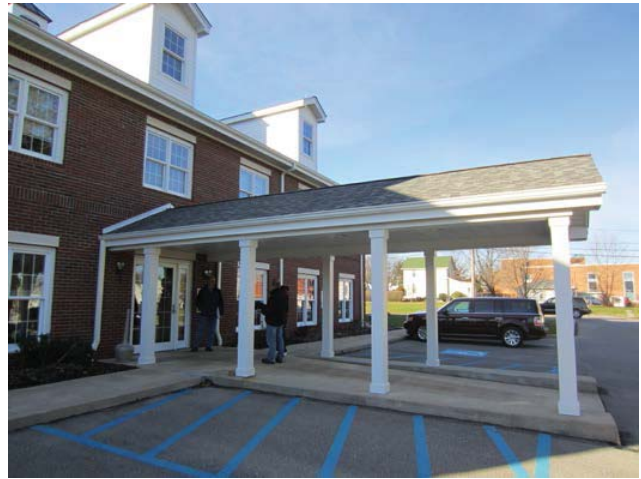
Figure 2: East façade of building with loggia

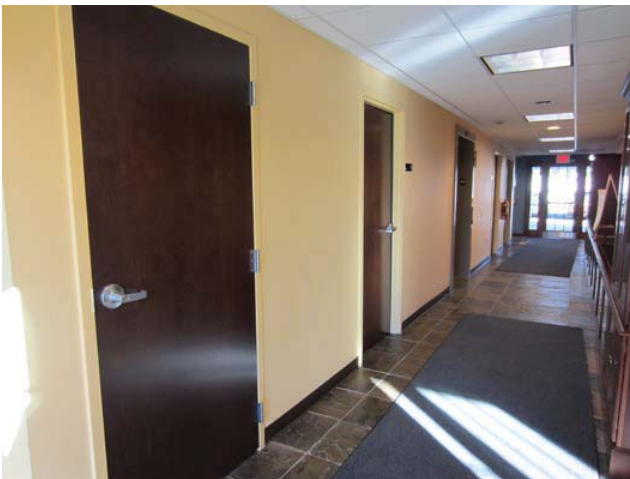
Figure 3: Interior corridor finishes

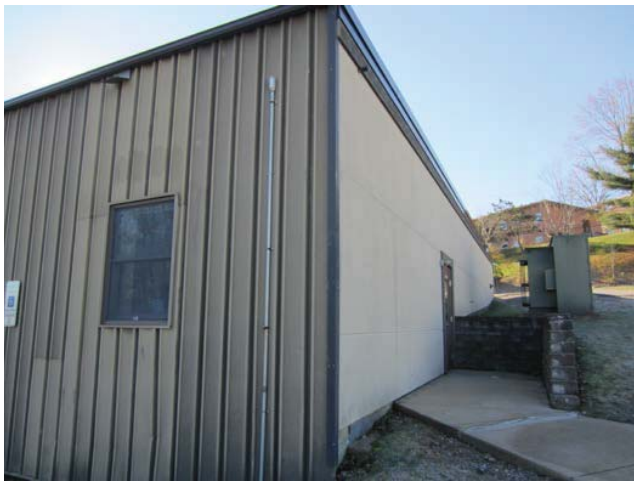
Figure 1: Northwest corner of building, with entrance beyond

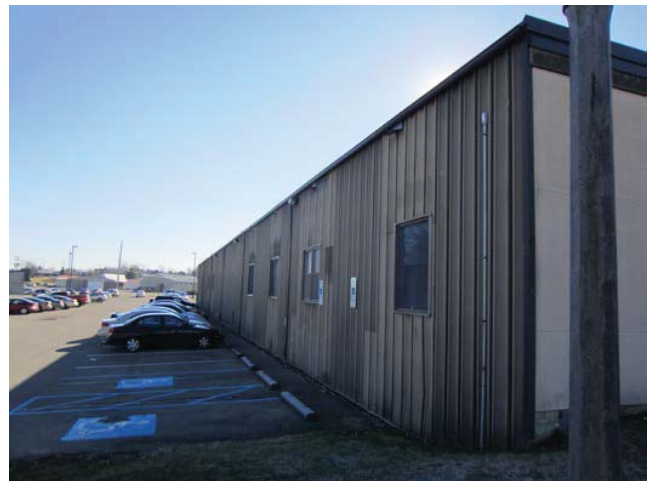
Figure 2: North façade of building

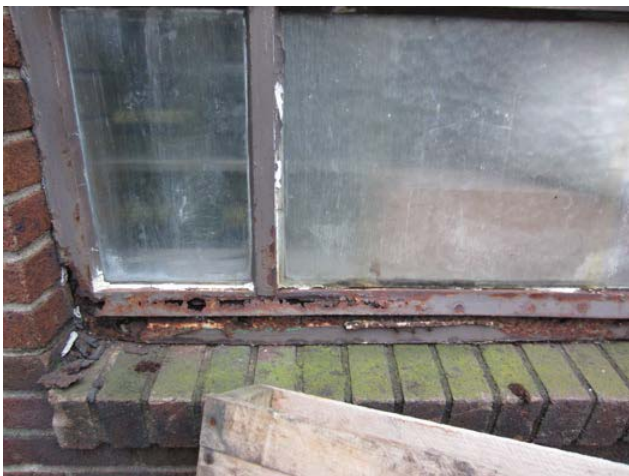
Figure 3: Window frame corrosion

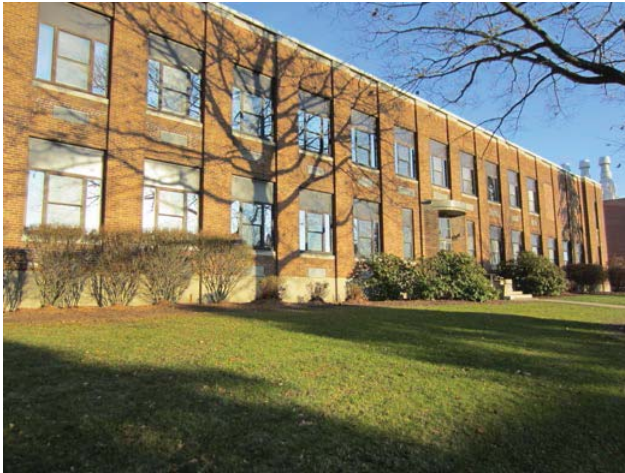
Figure 1: Davis Hall viewed from the west

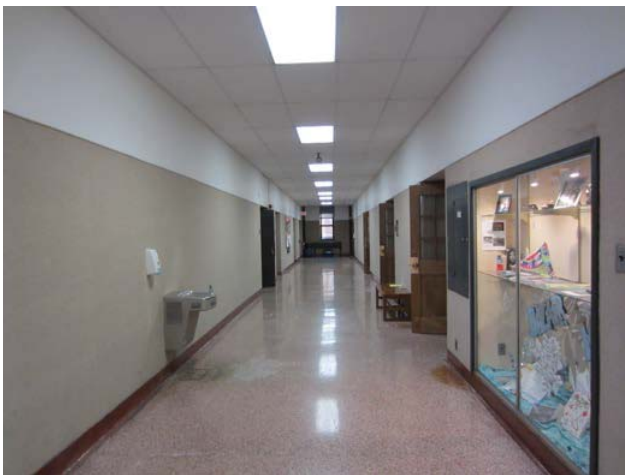
Figure 3: View of interior corridor with typical finishes

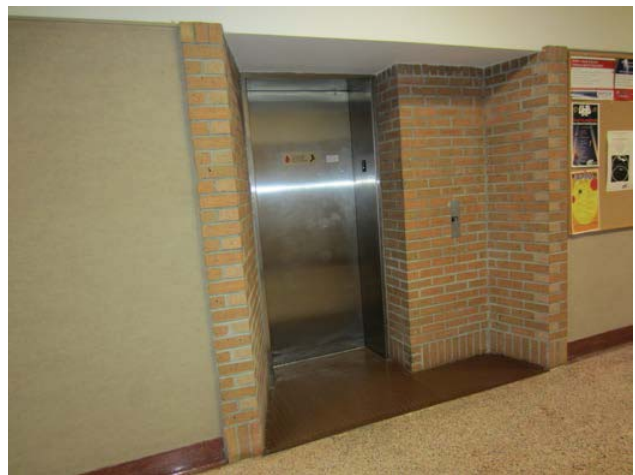
Figure 4: Elevator entrance cut into corridor construction

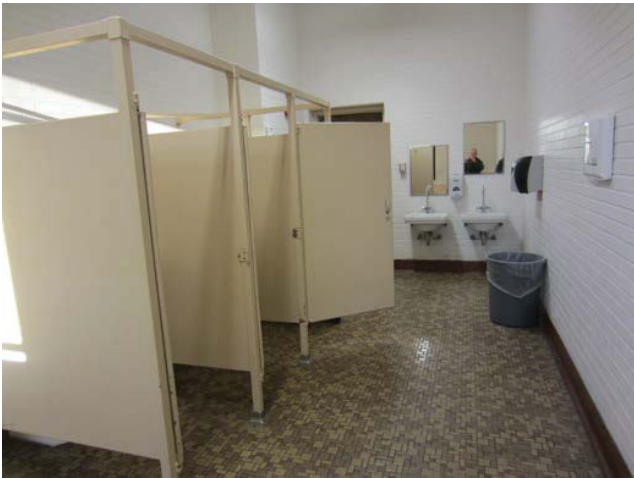
Figure 5: View of typical toilet room

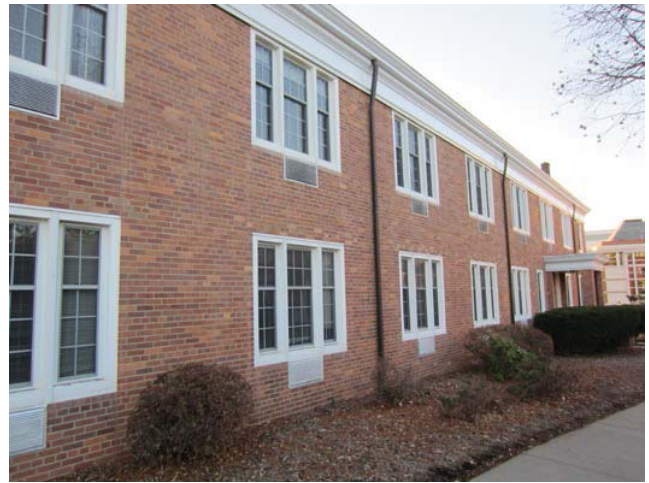
Figure 2: North façade of building

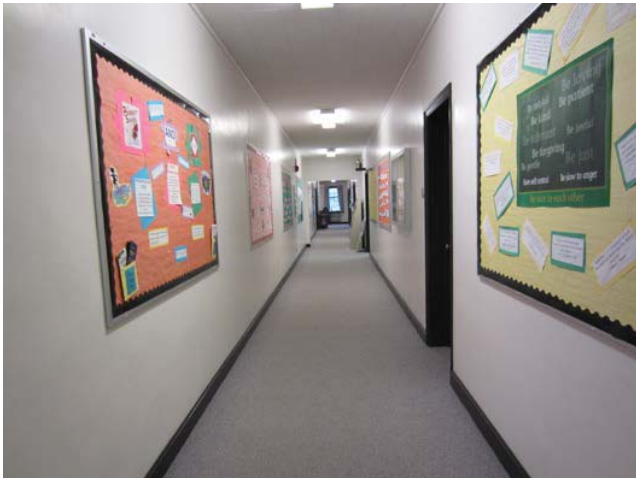
Figure 3: Interior corridor finishes

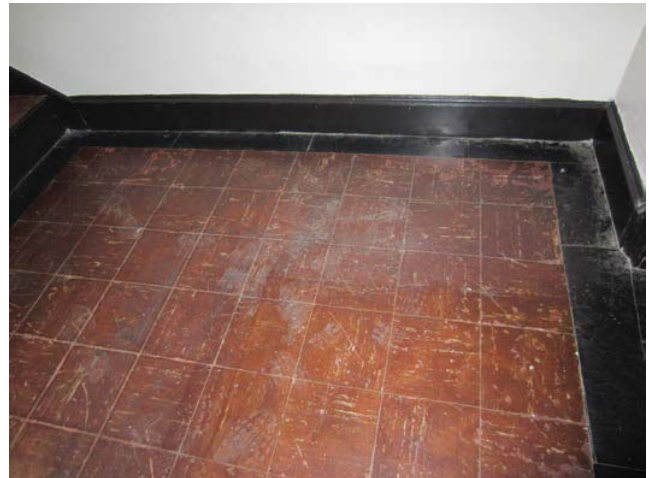
Figure 4: Possible asbestos floor tile at stair landing

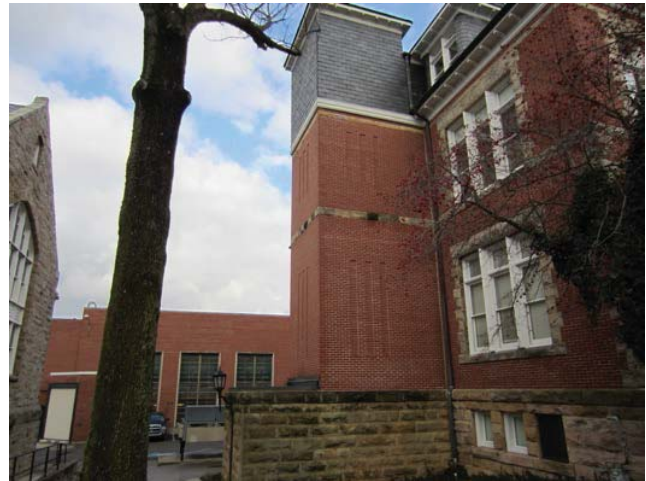
Figure 2: Elevator tower addition to west facade

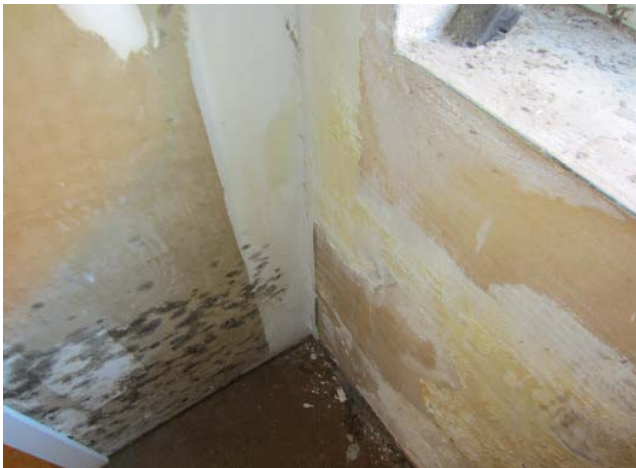
Figure 3: Possible moisture infiltration damage at basement

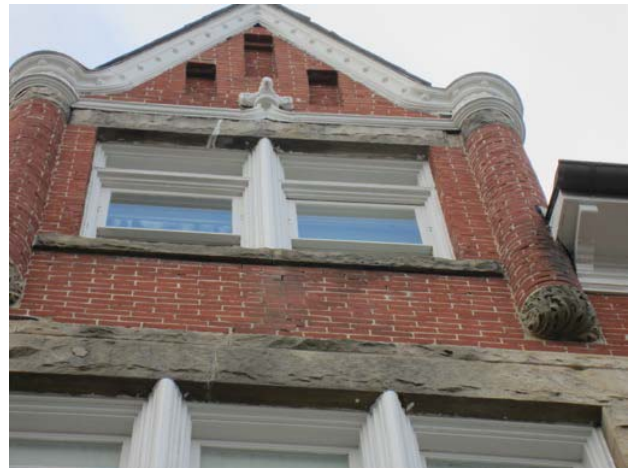
Figure 4: Cracked masonry and mortar loss on east facade

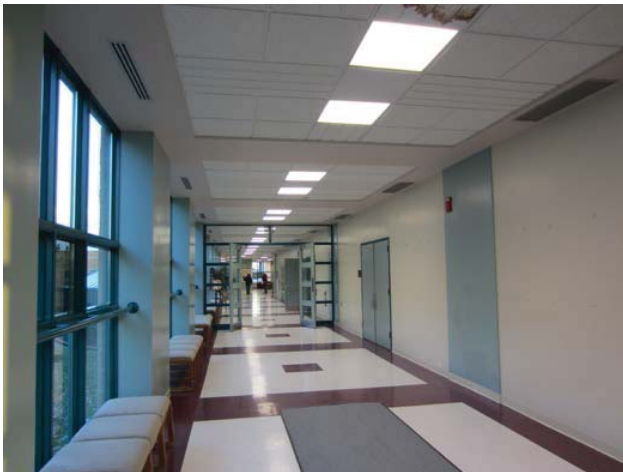
Figure 3: Typical finishes at entry corridor

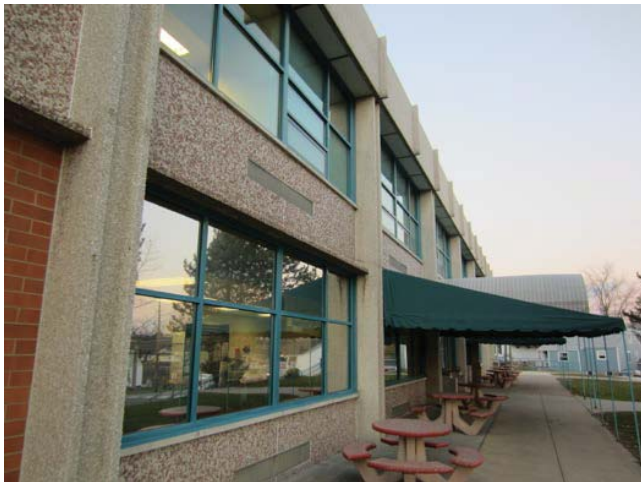
Figure 5: South façade at Riemer Student Center portion of building (older wing of Student Union)

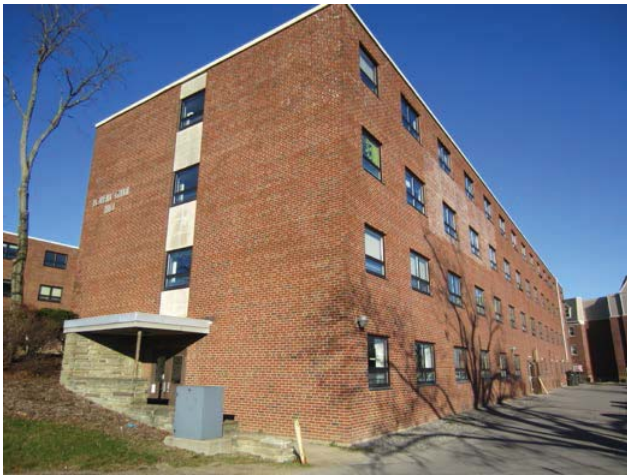
Figure 1: Givan Hall east façade with basement floor at grade

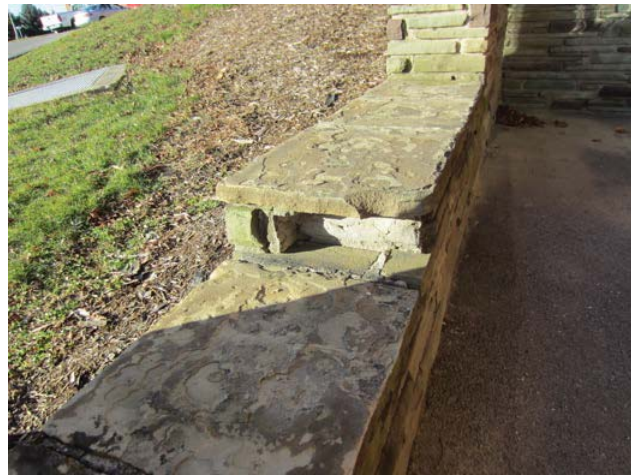
Figure 2: Fieldstone wall conditions at entrances (typical)

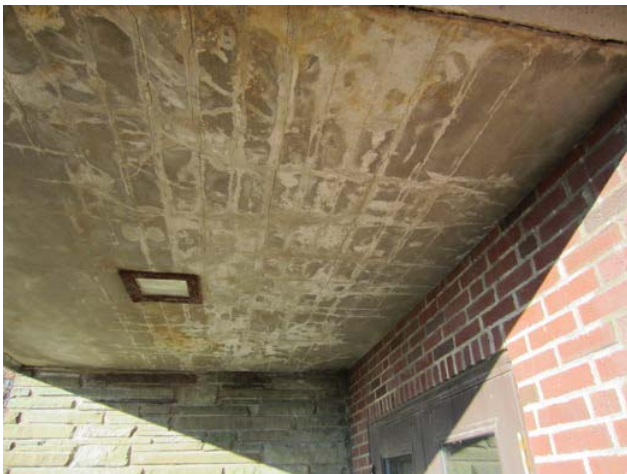
Figure 3: Concrete soffit corrosion at entrance

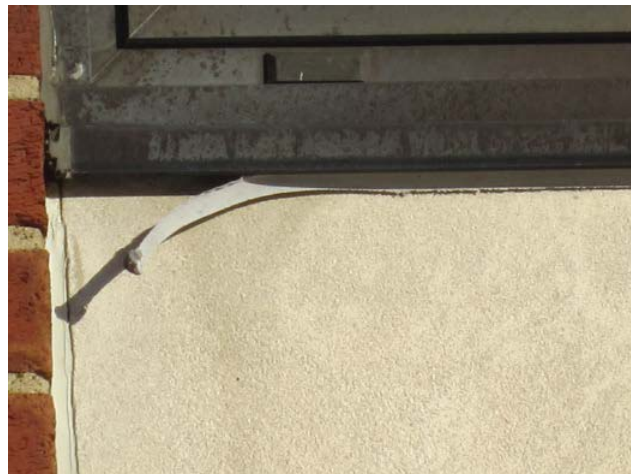
Figure 4: Sealant failure at limestone panel

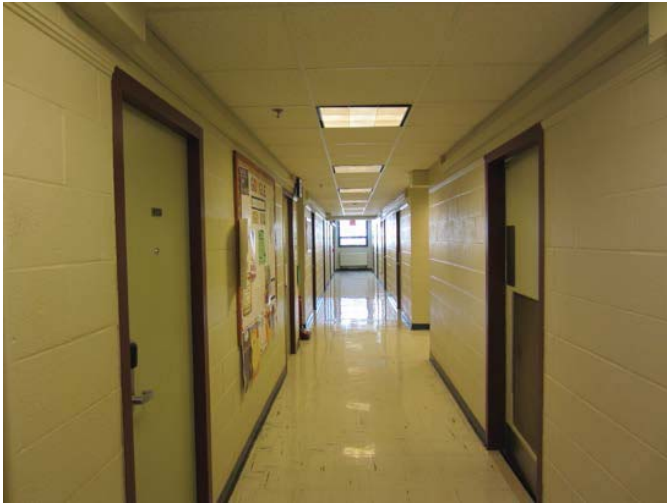
Figure 5: Interior corridor, typical finishes

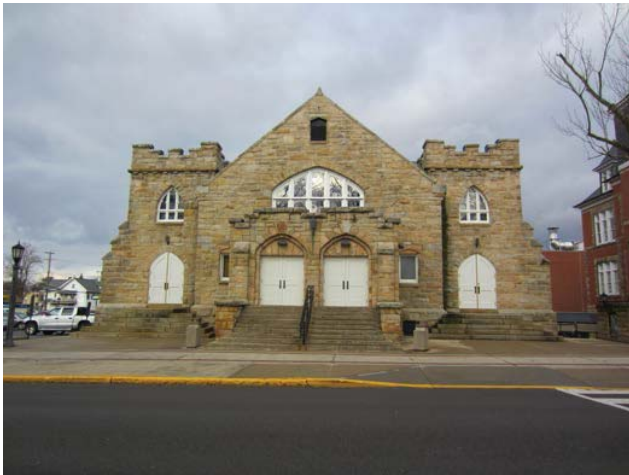
Figure 1: South façade of Hart Chapel

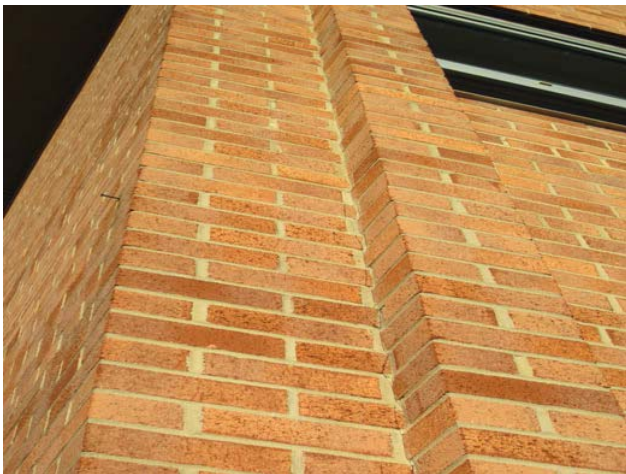
Figure 3: Vertical crack at inside corner of masonry, southeast corner of building

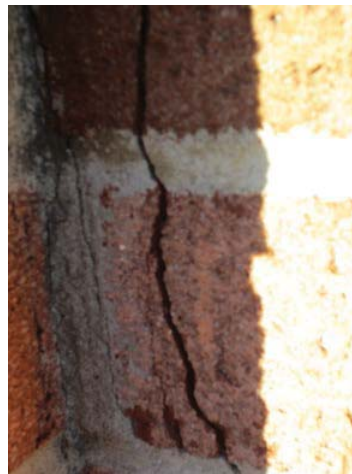
Figure 4: Cracked brick masonry on east facade

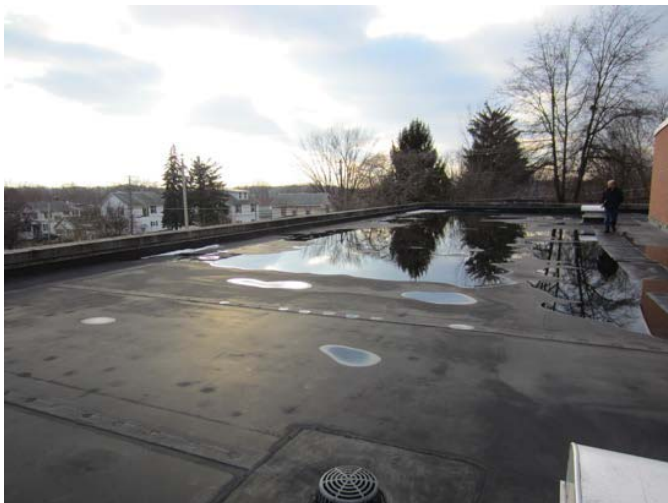
Figure 5: Roof water ponding

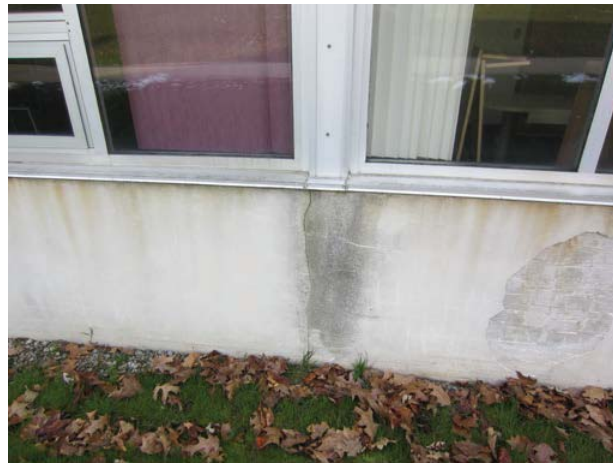
Figure 2: Cement Plaster Cracking and Spalling

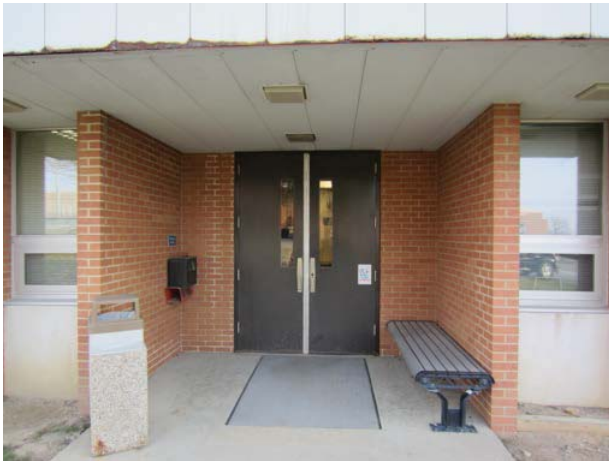
Figure 3: Canopy Corrosion at Entrance

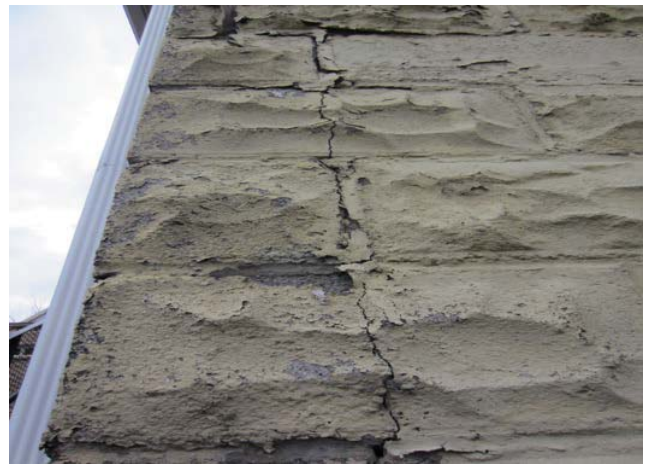
Figure 2: Cracked masonry and open mortar joints (typical)

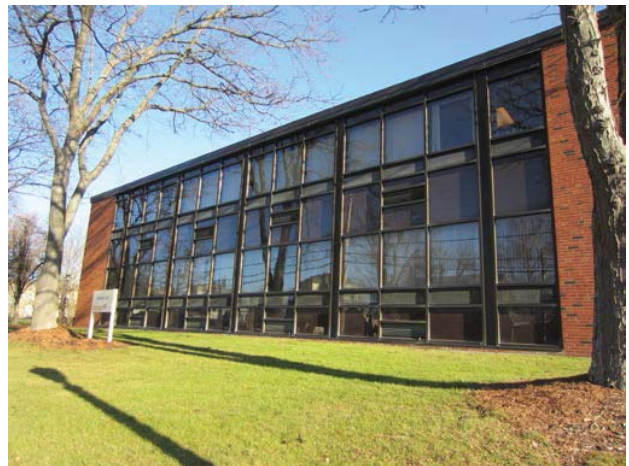
Figure 2: West façade curtain wall enclosure

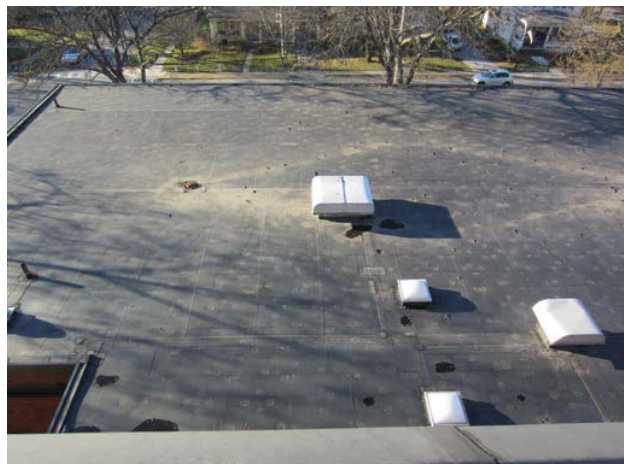
Description The building roofing consists of a mechanically fastened membrane, with flashing. Aluminum coping is installed at the roof perimeter.
Condition The membrane appears to be in good condition. The age of the roof is unknown.
Rating: 2.5
Recommendations Periodic inspections and maintenance are recommended to maintain existing roof conditions.

Figure 4: Membrane Roof at Annex

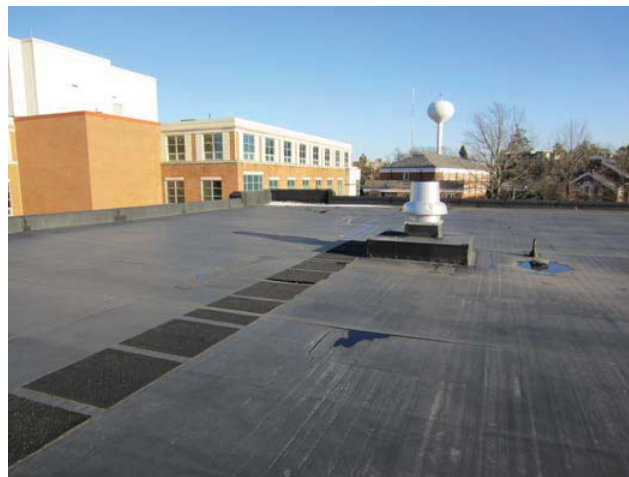
Figure 4: View of membrane roofing

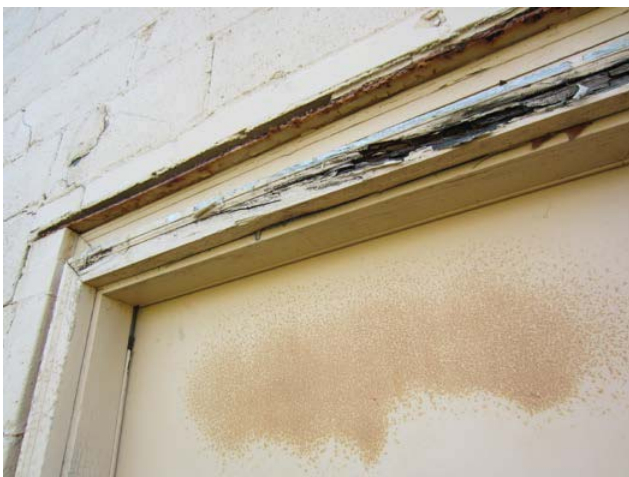
Figure 3: Exterior door corrosion and frame deterioration

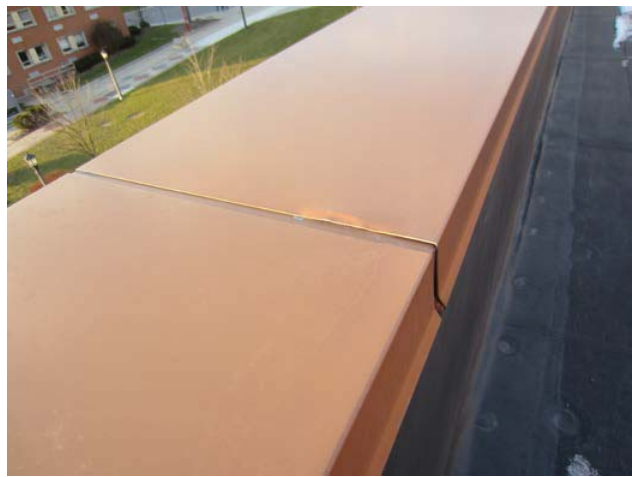
Figure 4: Membrane roofing and aluminum coping

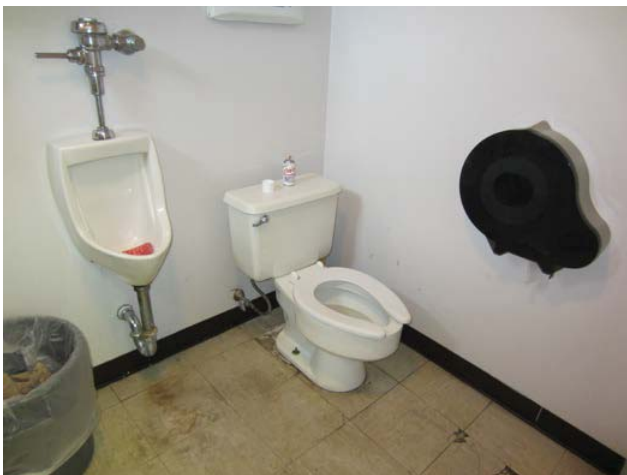
Figure 3: Damaged floor finish at toilet room

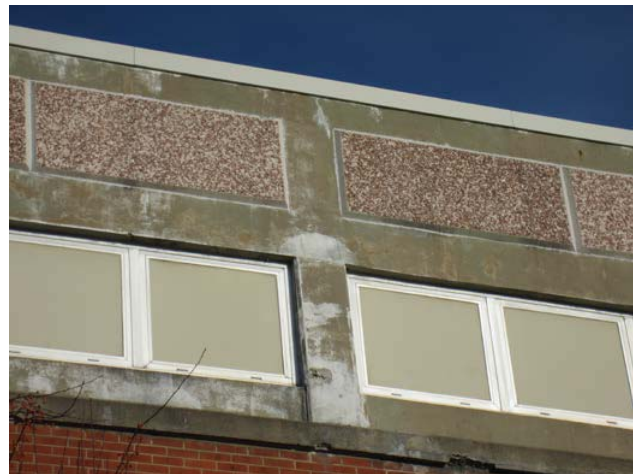
Figure 2: Concrete cracking and spalling

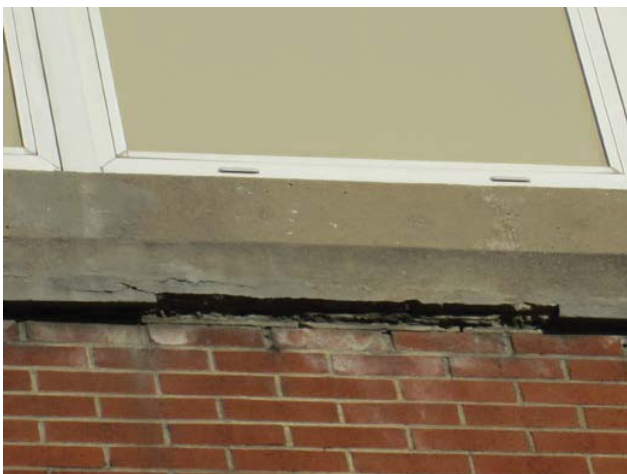
Figure 3: Concrete spalling and reinforcement corrosion

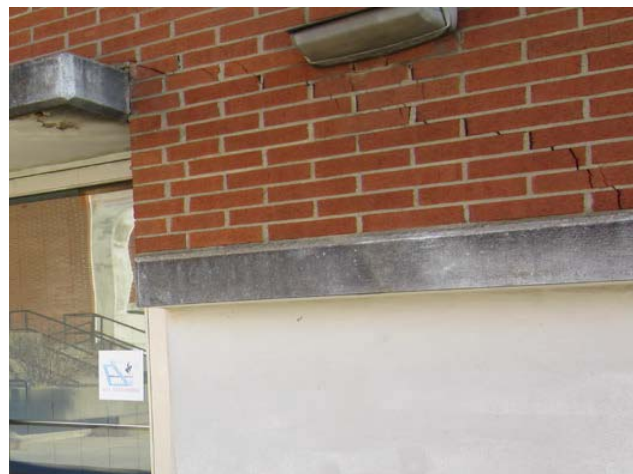
Figure 4: Cracks in brick masonry and mortar

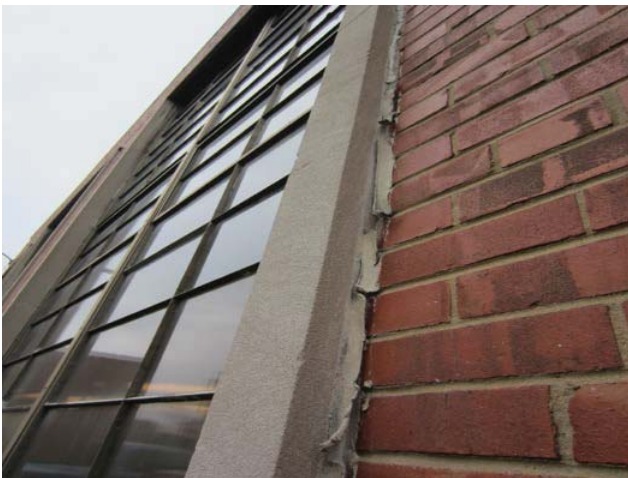
Figure 3: Sealant failure between limestone and brick masonry
