CLARION UNIVERSITY | CLARION CAMPUS
Facilities Master Plan Appendix

D BUILDINGS LAYOUTS AND ASSESSMENT

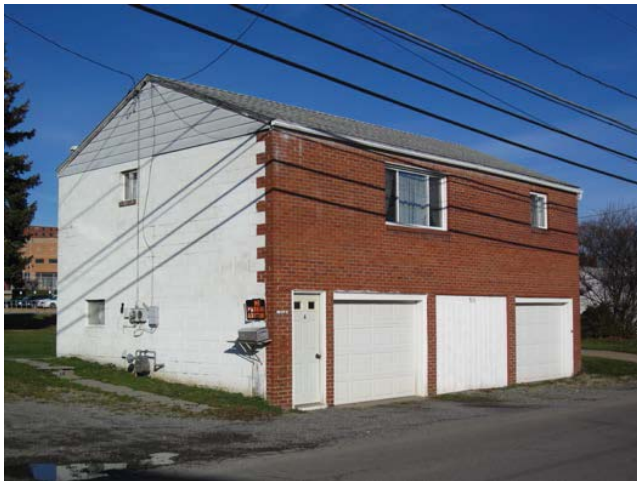
Figure 1: 915 Corbett Street exterior view

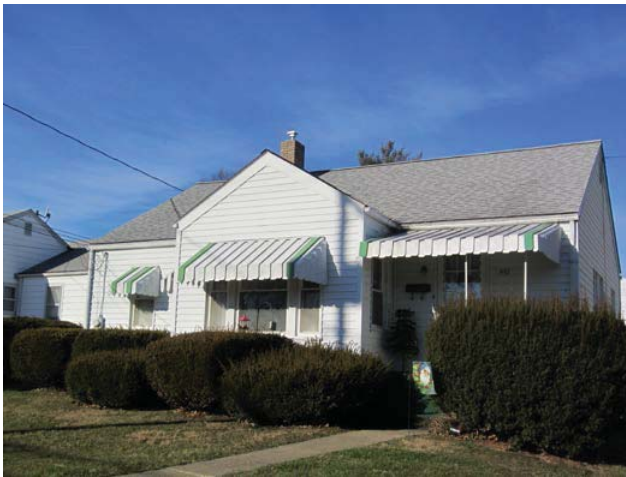
Figure 1: 957 Corbett Street exterior view

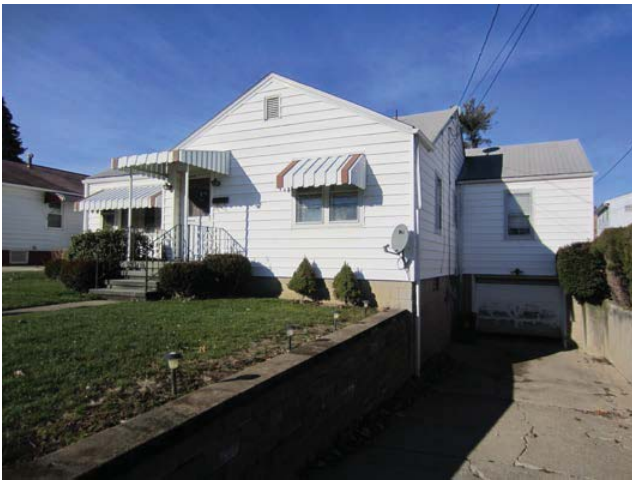
Figure 1: 959 Corbett Street exterior view

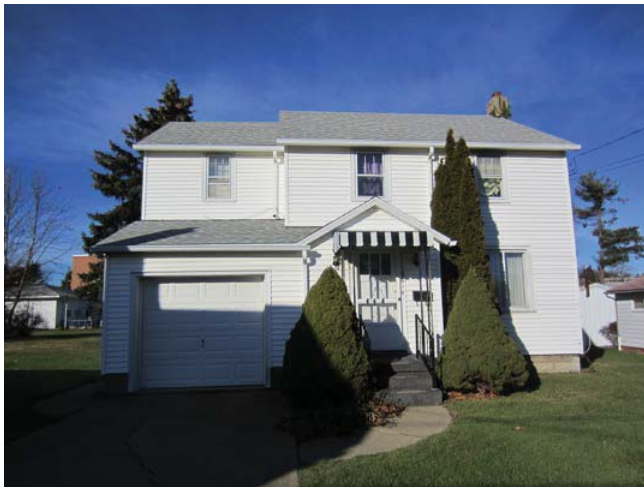
Figure 1: 961 Corbett Street exterior view

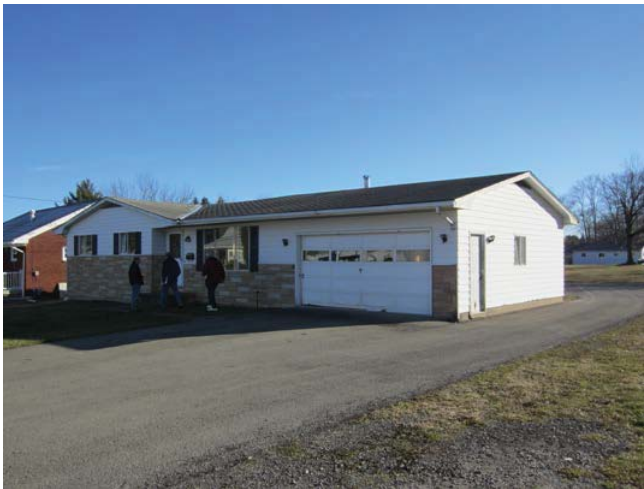
Figure 1: 962 Corbett Street exterior view

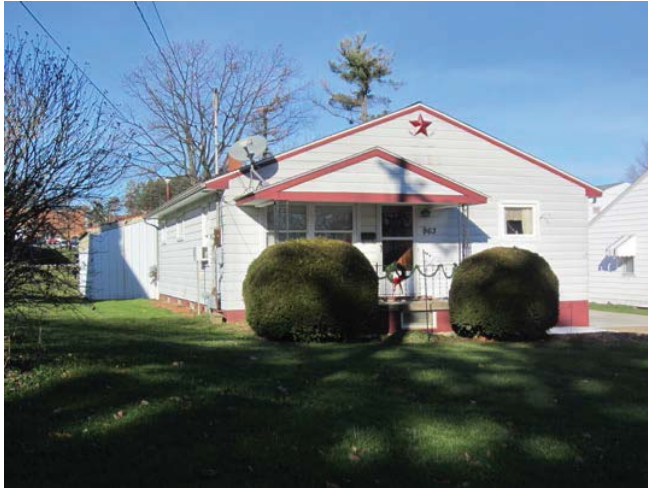
Figure 1: 963 Corbett Street exterior view

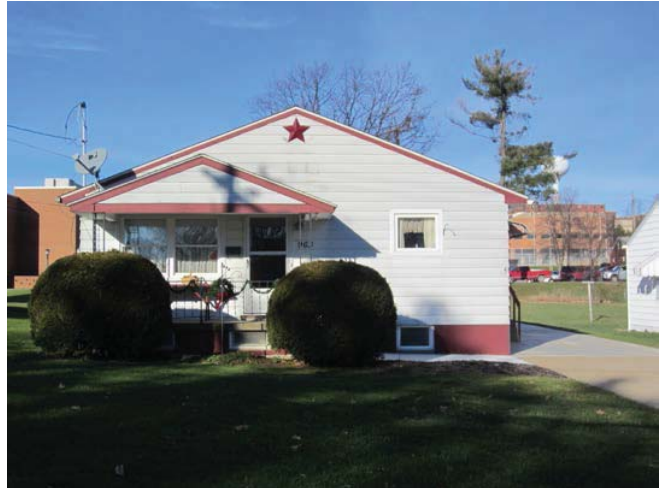
Figure 2: 963 Corbett Street exterior view

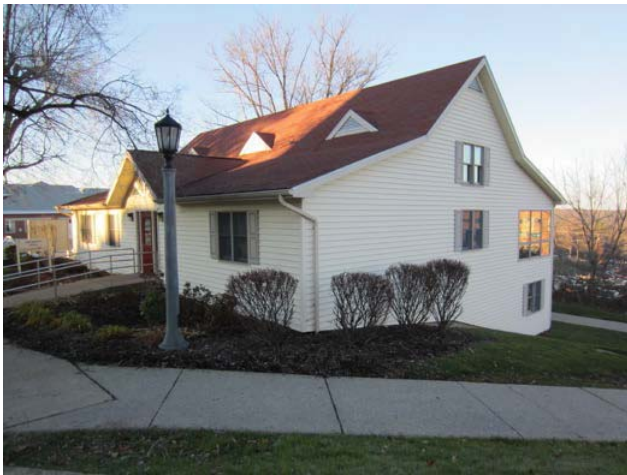
Figure 1: South and east facades of Admissions Building

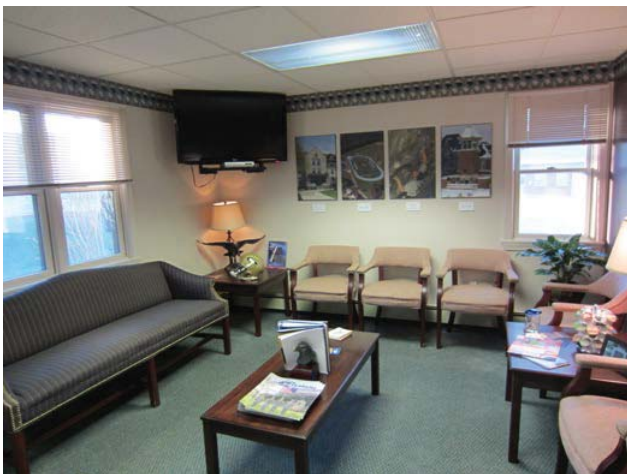
Figure 3: View of waiting room

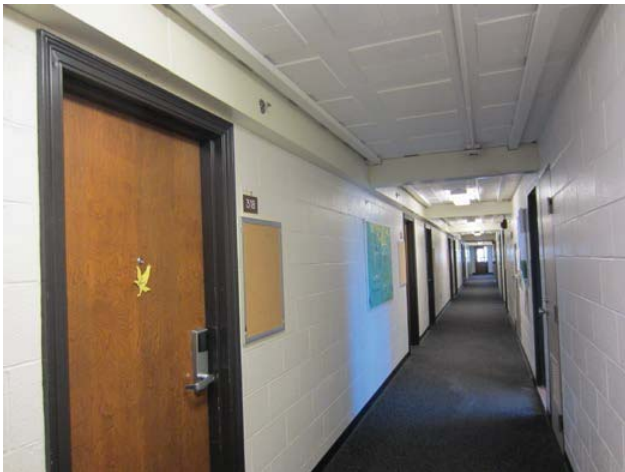
Figure 3: Interior view of resident room corridor

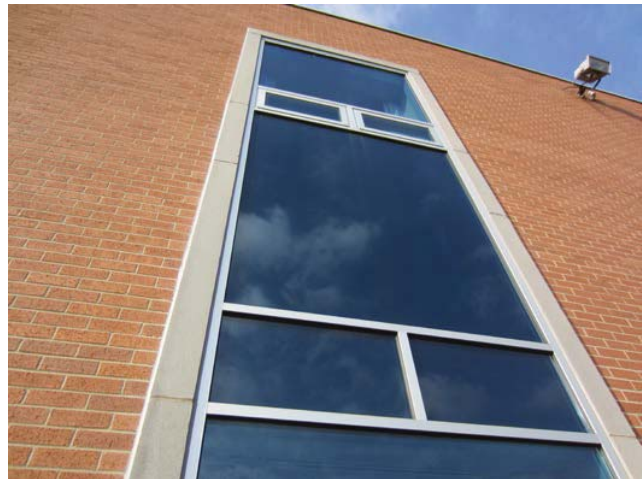
Figure 2: Typical multi-story window units

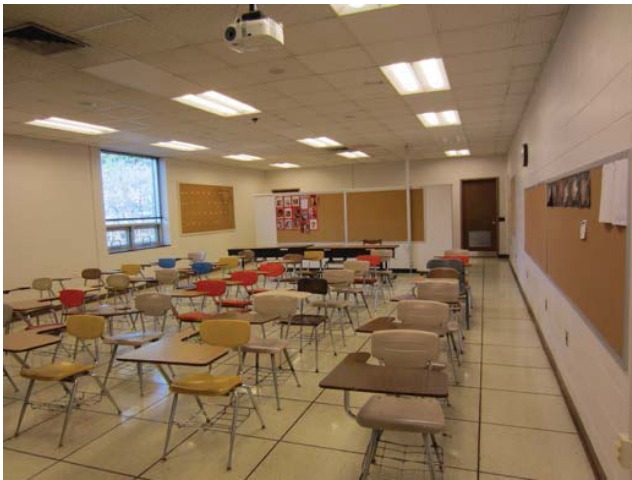
Figure 5: Classroom view

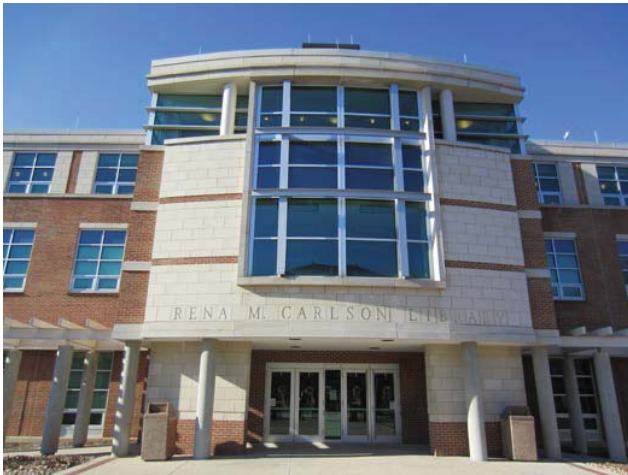
Figure 1: Carlson Library Main Entrance

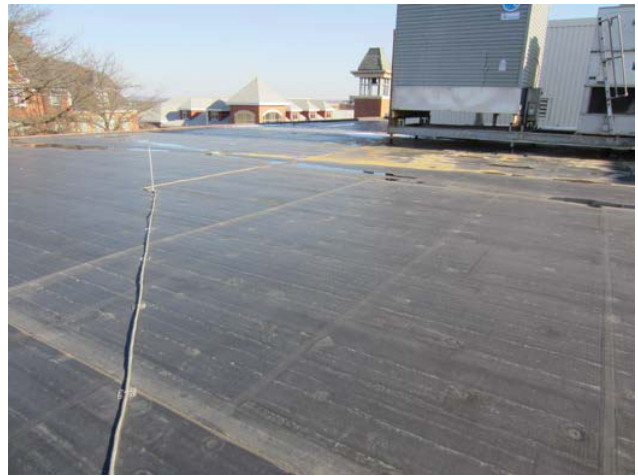
Figure 4: Membrane roof assembly

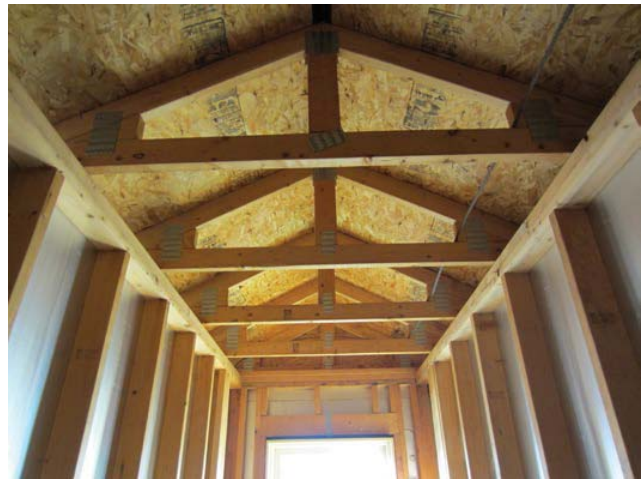
Figure 4: Attic construction

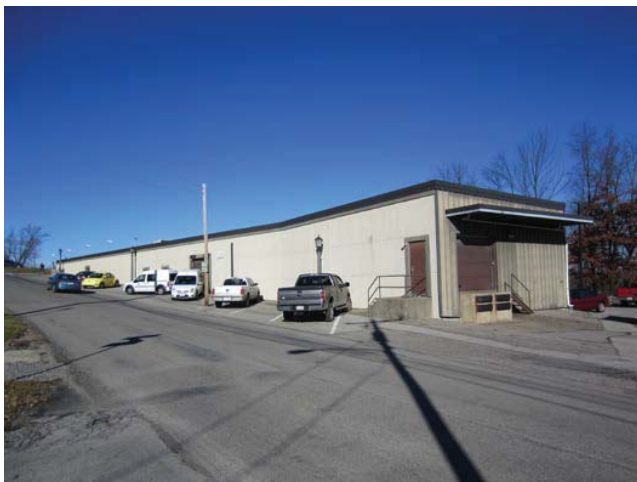
Figure 3: South and east building facades

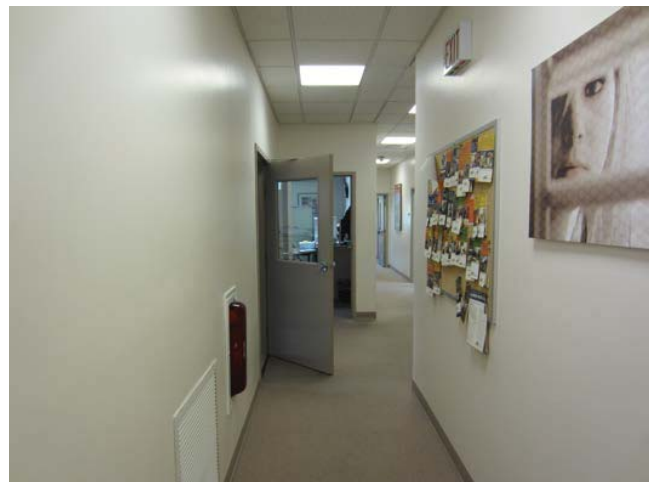
Figure 4: Interior corridor

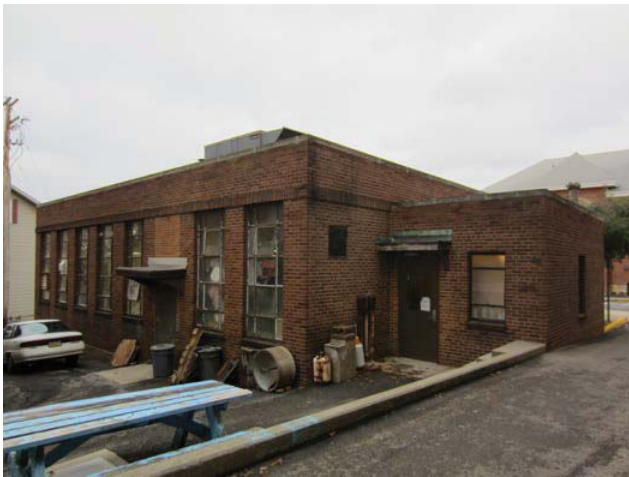
Figure 1: West façade of Ceramics Laboratory

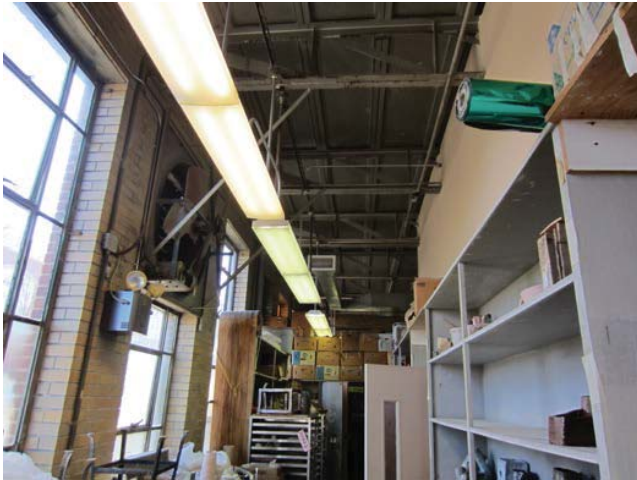
Figure 5: Ceramic Laboratory Interior

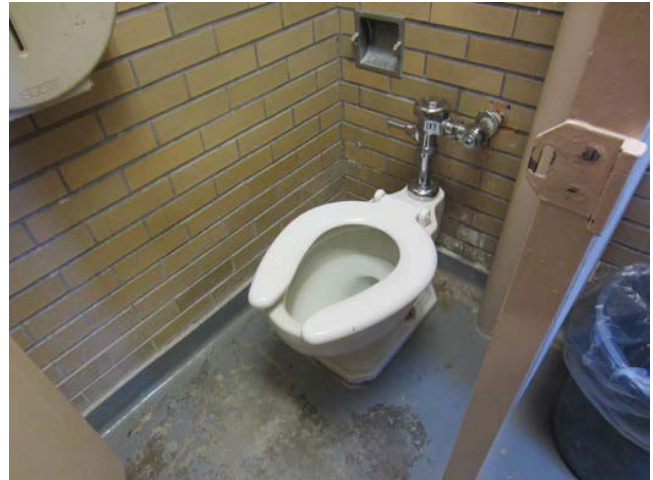
Figure 6: Toilet room finishes

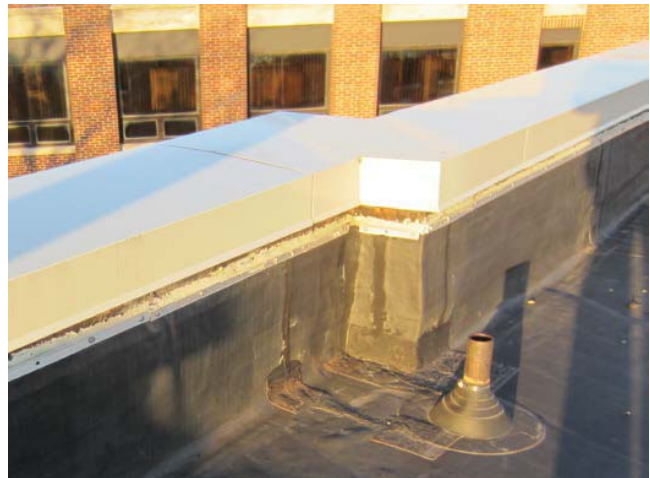
Figure 6: Roof construction with flashing bar below coping

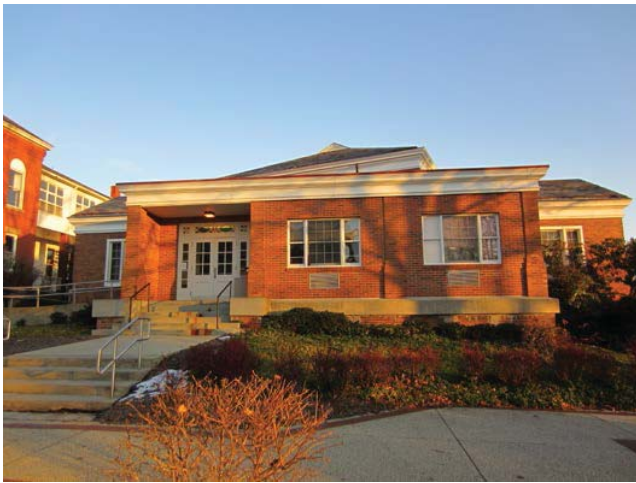
Figure 1: West façade of Egbert Hall

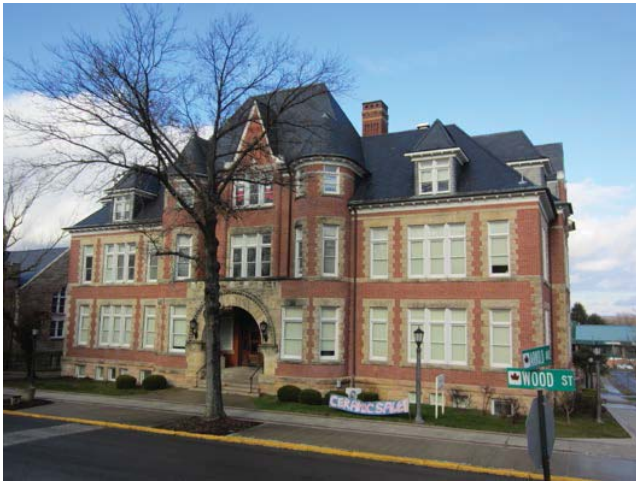
Figure 1: South façade of Founders Hall

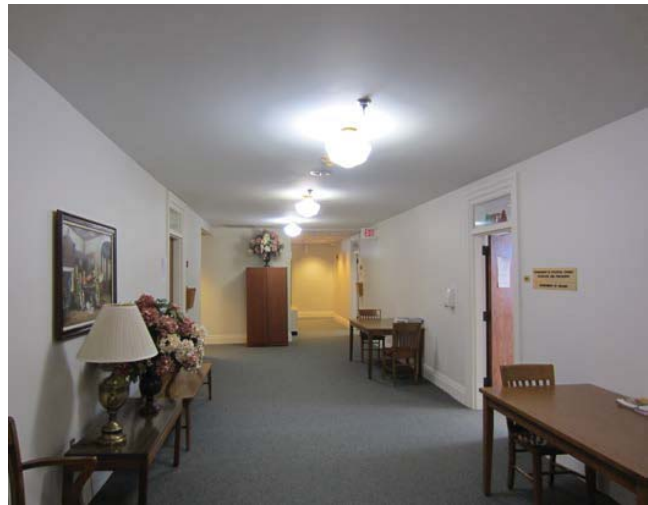
Figure 6: Corridor interior finishes

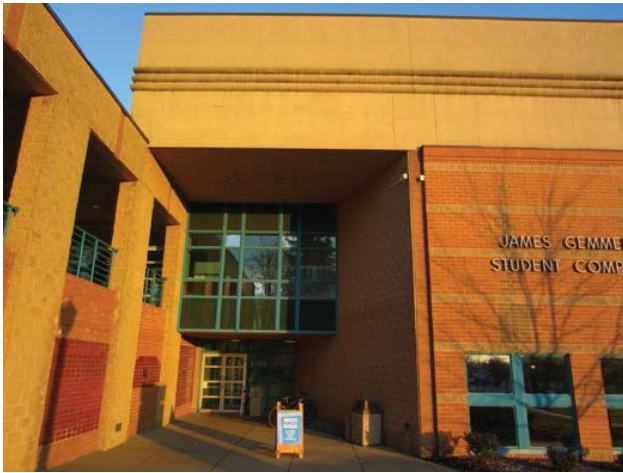
Figure 1: Gemmell Student Union entrance

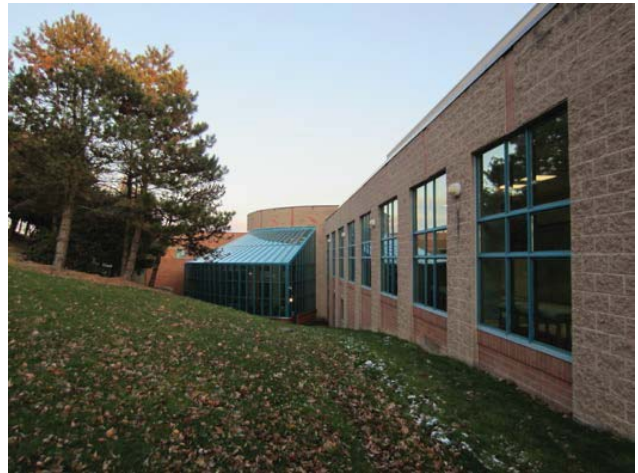
Figure 2: North façade, with lounge greenhouse beyond

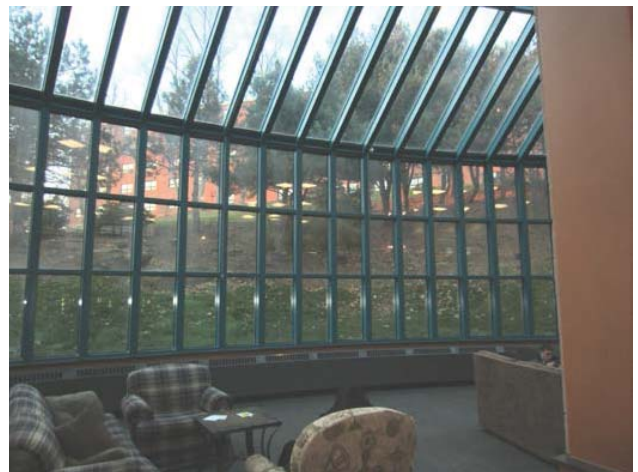
Figure 4: Lounge interior

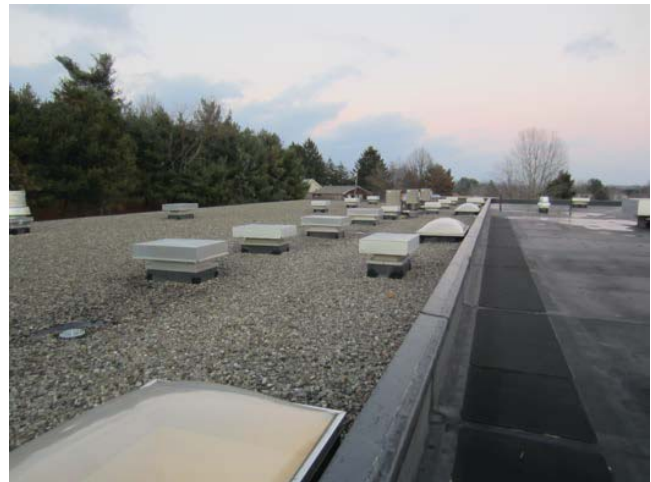
Figure 6: Membrane roof assemblies, with and without ballast

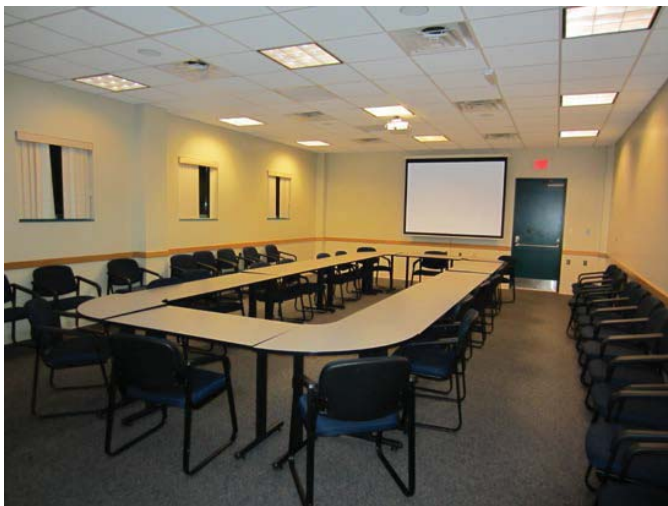
Figure 5: Meeting room interior

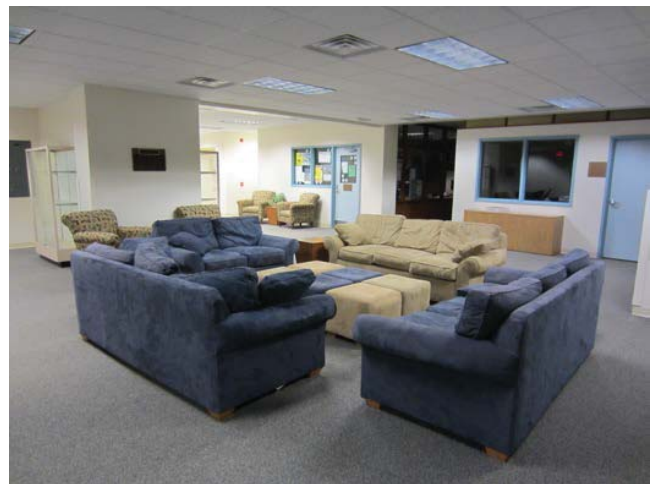
Figure 6: Lounge with student association offices beyond

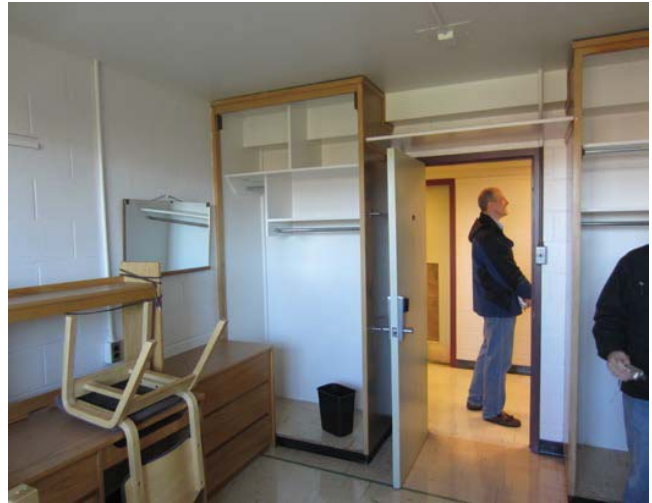
Figure 6: Resident room finishes and wardrobes

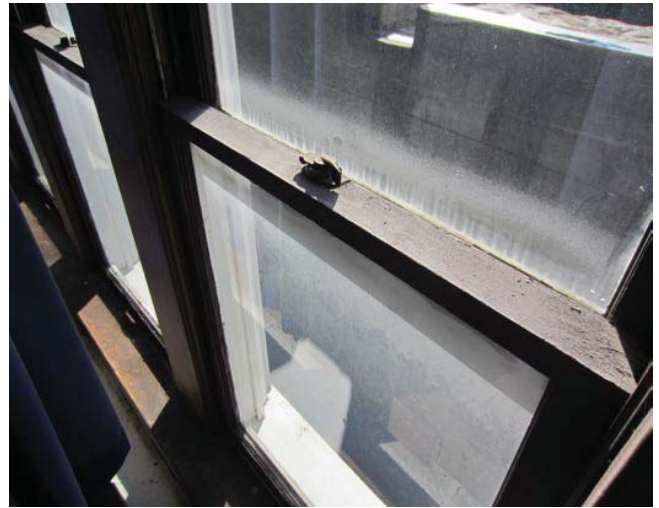
Figure 6: Typical operable wood and glass window

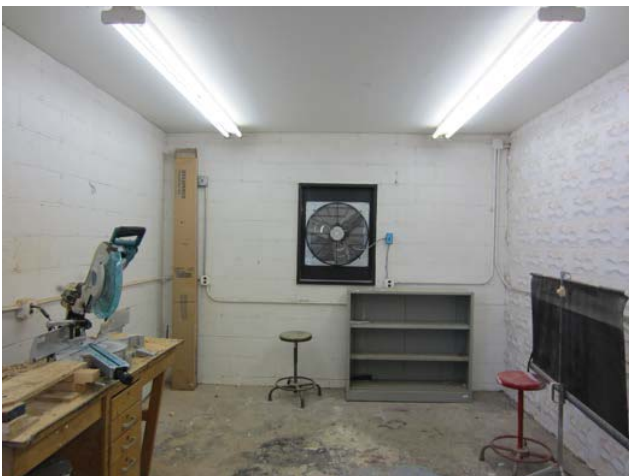
Figure 3: View of interior

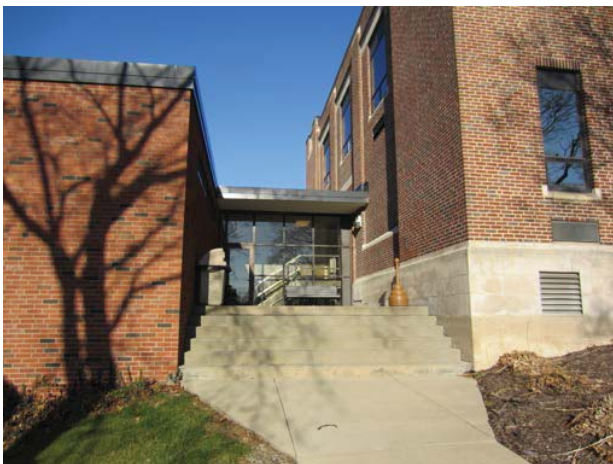
Figure 3: View of link between Stevens Hall and the Annex
